# Classification of Modern Vehicle Hazards in Parking Structures & Systems – Ph II

Final Report by:

**Stephen Olenick, Michael Klassen, Nasir Hussain**  
Combustion Science & Engineering  
Maryland, USA

May 2024

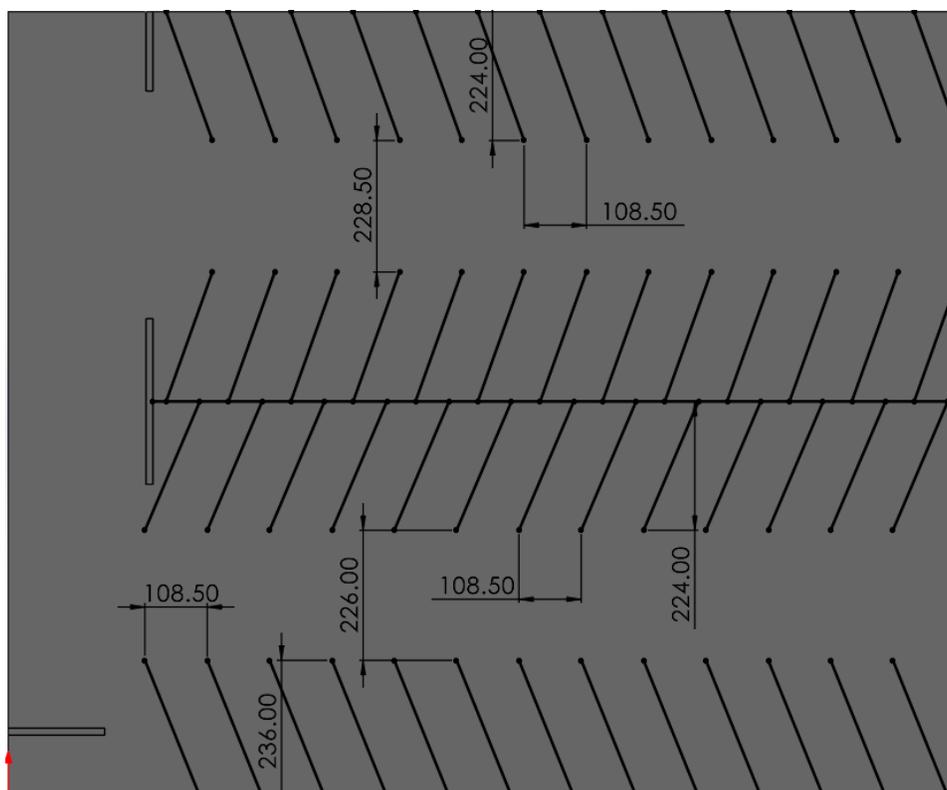
Figure 17. Scale diagram of Merriweather parking garage in the location of the fire with parking space dimensions (in inches). Source (CSE site visit).

As can be seen in Figure 17, the width projection of the parking spaces in this area is approximately 9 feet 0.5 inches (2.76m). From other dimensions, the angle of the parking spaces was calculated as 67°. Referring to Figure 3, for a space with an angle between 65° and 70°, the minimum level of comfort width projection is between 8'9" (2.67 m) and 9'1" (2.77 m) and the

maximum level of comfort width projection is between 9'7" (2.92 m) and 9'11" (3.02 m). This indicates that the parking spaces in this garage are within the recommended width projections based on the design vehicle, but are on the tight side with a minimum level of comfort. Therefore, this results in a relatively worst-case scenario for car to car spread for cars in adjacent spaces. As mentioned above, damage was sustained on an automobile separated by one empty space (vehicle #6). Additionally, damage was also incurred on an automobile at least 18'10" (5.74 m) away (vehicle #7), which is the equivalent of at least two empty spaces away. This behavior is consistent with the testing by BRE [18], where a fire was able to skip over an empty parking spot to ignite a vehicle after more than one vehicle was already burning. This indicates that while the spaces in this garage were on the relatively small end of the recommended range, the fire was indeed capable of spreading and was beginning to damage automobiles significantly further away than the largest recommended parking space size. The fire likely would have continued to spread to multiple vehicles and likely would have still damaged vehicles even further than one space away, possibly igniting them had the incident continued without Fire Department intervention.

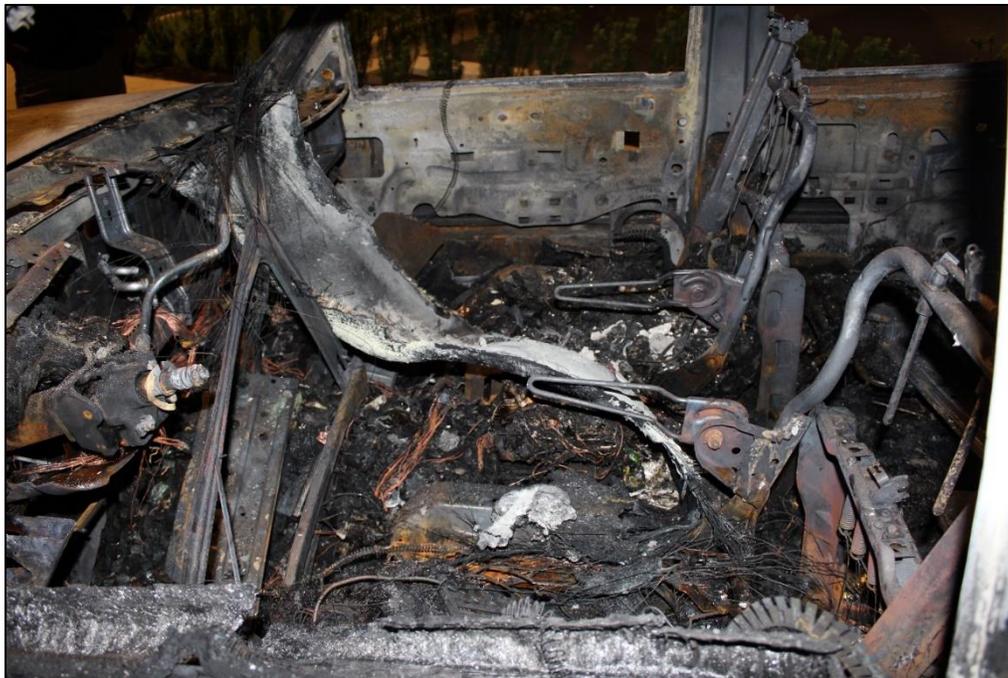
As mentioned, the physical evidence indicated that the fire originated either in vehicle #1 or vehicle #2. Specifically, the front of vehicle #1 or the rear of vehicle #2. Witness testimony indicates that vehicle #1 was potentially seen by a bystander issuing smoke. Based on this information, the HCDFRS investigator indicated the most likely origin of the fire was the engine compartment of vehicle #1, but could not rule out the rear of vehicle #2 and therefore described the fire origin as undermined.

Figure 18. Fire-related damage to the interior of Vehicle #1 (source: HCDFRS photo IMG\_0236.JPG)

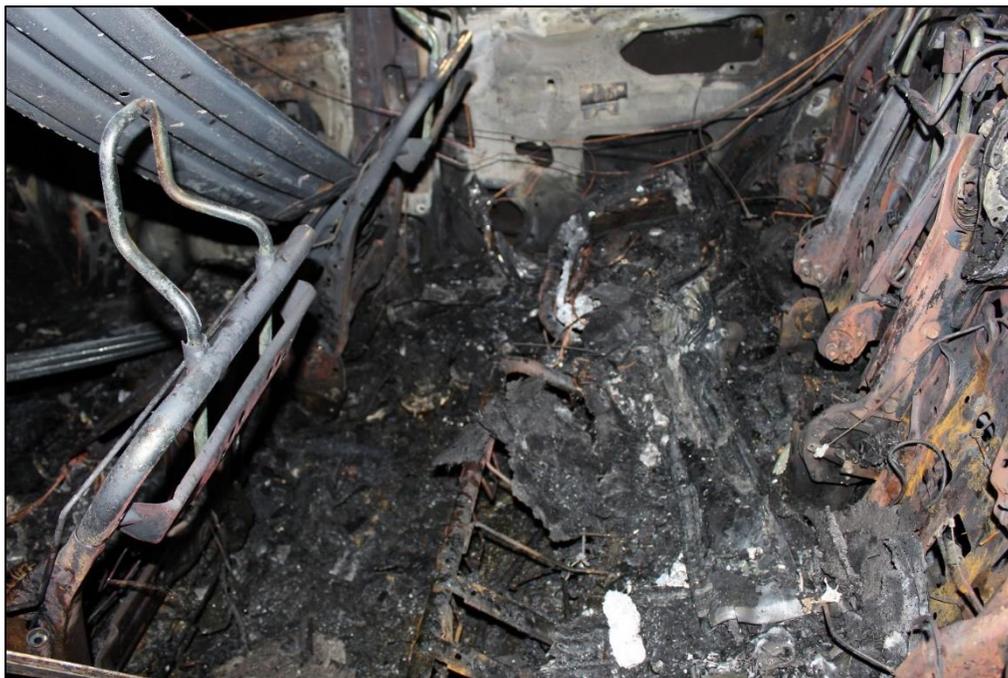
Figure 19. Fire-related damage to the interior of Vehicle #4 (source: HCDFRS photo IMG\_0114.JPG)

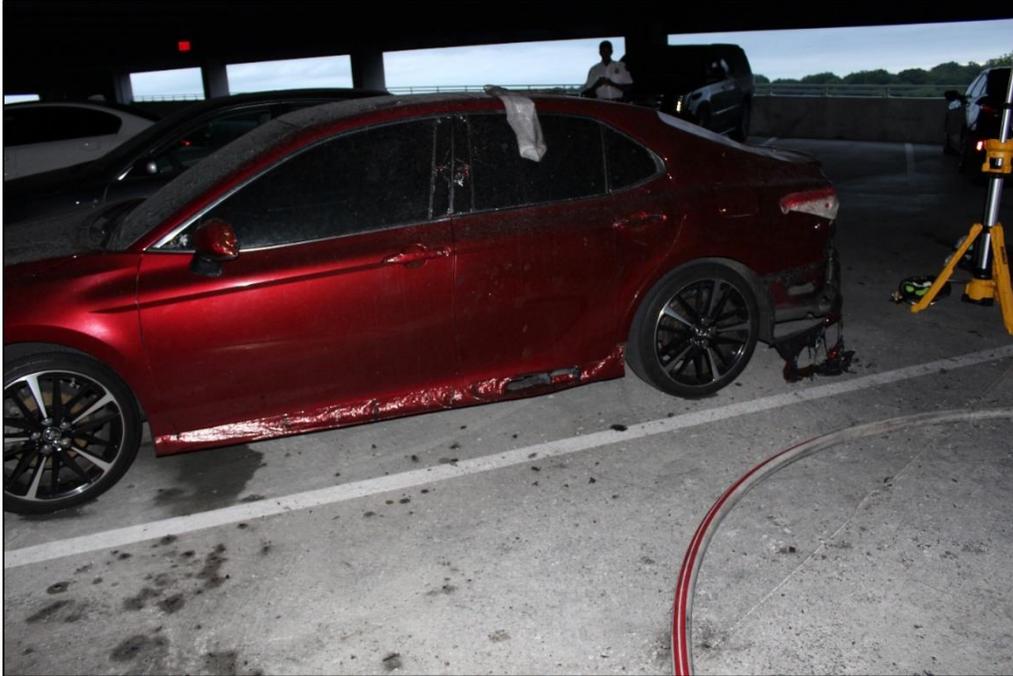
Figure 20. Vehicle #6 fire-related damage (source: HCDFRS photo IMG\_0049.JPG)

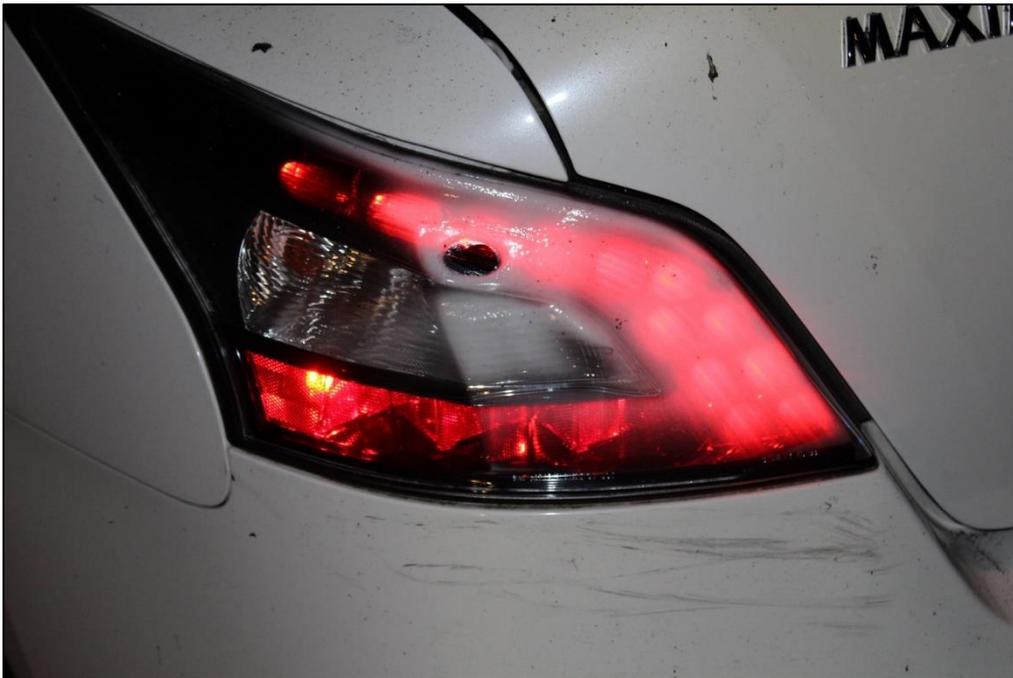
The parking garage was of the “open” type and presumably was built before fire codes required sprinkler systems in open-type garages. The fire was able to spread from whichever vehicle (#1 or #2) was the originating vehicle to the other. A photograph of vehicle #1 is shown as Figure 18. The vehicle immediately next to vehicle #1 (vehicle #4) also had substantial heat and fire damage and appeared to be significantly if not completely consumed. The interior of vehicle #4 is shown as Figure 19. As the distance increased from the originating vehicle(s), the damage began to lessen. Vehicle #6, which was separated from vehicle #4 by an additional empty space, showed melting damage to the side of the vehicle, as seen in Figure 20. Vehicle #7, which was across the aisle from vehicle #1, was also beginning to show some melting damage to the components on the rear of the automobile, specifically the taillight as mentioned in the HCDFRS report. A photo is included as Figure 21.

Figure 21. Vehicle #7 fire-related damage (source: HCDFRS photo IMG\_0141.JPG)

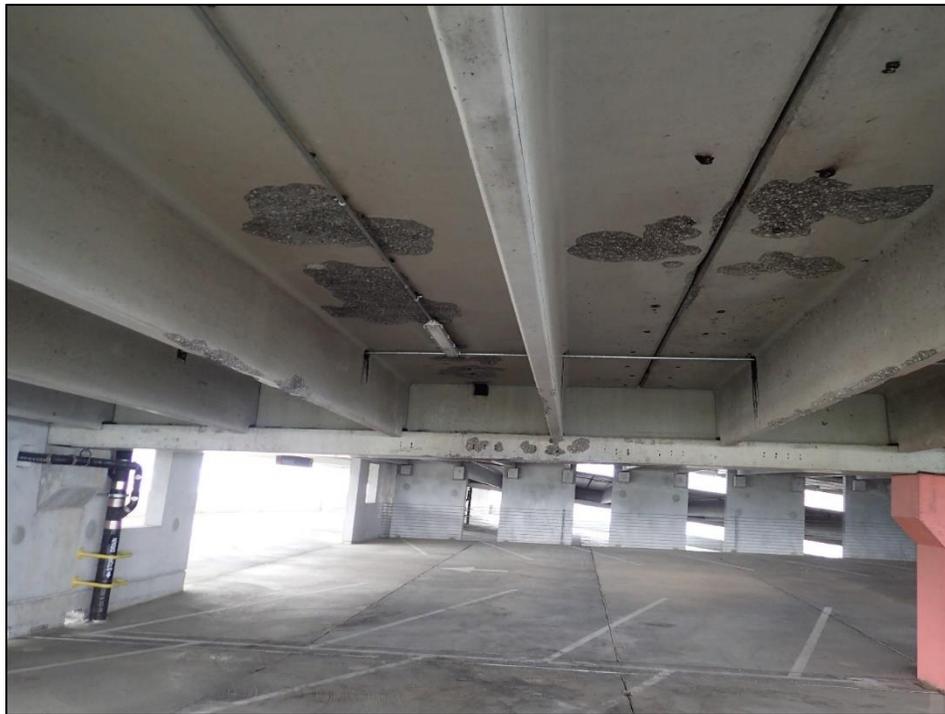
The beginning of some spalling on the ceiling of level 6 was also mentioned in the HCDFRS report and some photos were included in the report. The initial spalling was still present when CSE visited the site several months later (06/2023), as can be seen in Figure 22, and some remediation had taken place when CSE re-visited the site in January, 2024, as seen in Figure 23.

Figure 22. Spalling on the upper portion of level 6 in the parking garage near Merriweather Post Pavilion. (source: CSE post-fire site visit – 06/2023)

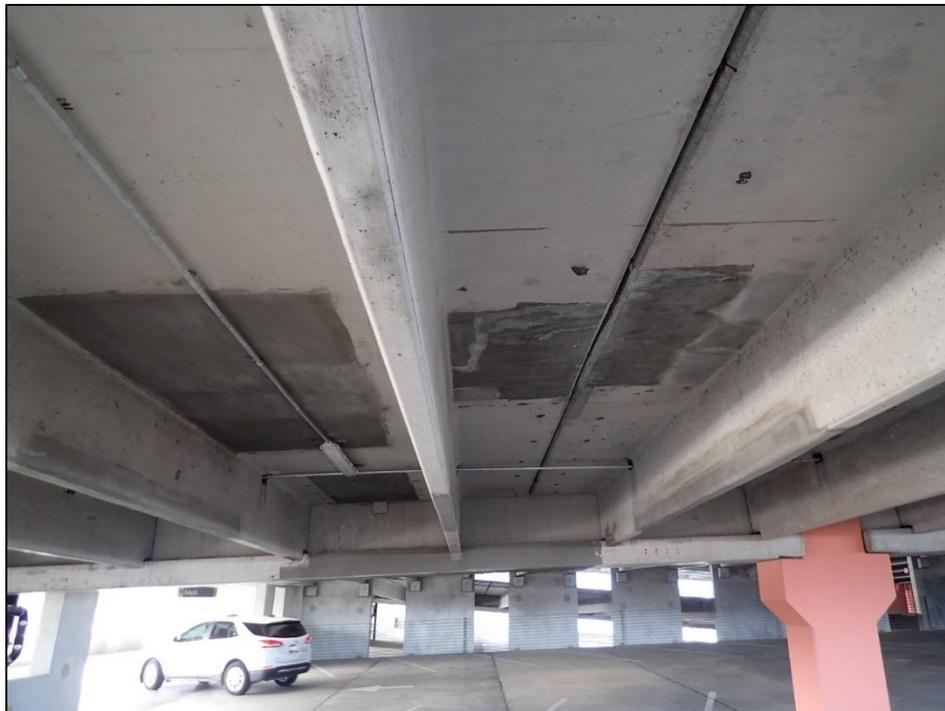
Figure 23. Remediated spalling on the upper portion of level 6 in the parking garage near Merriweather Post Pavilion. (source: CSE post-fire site visit – 01/2024)

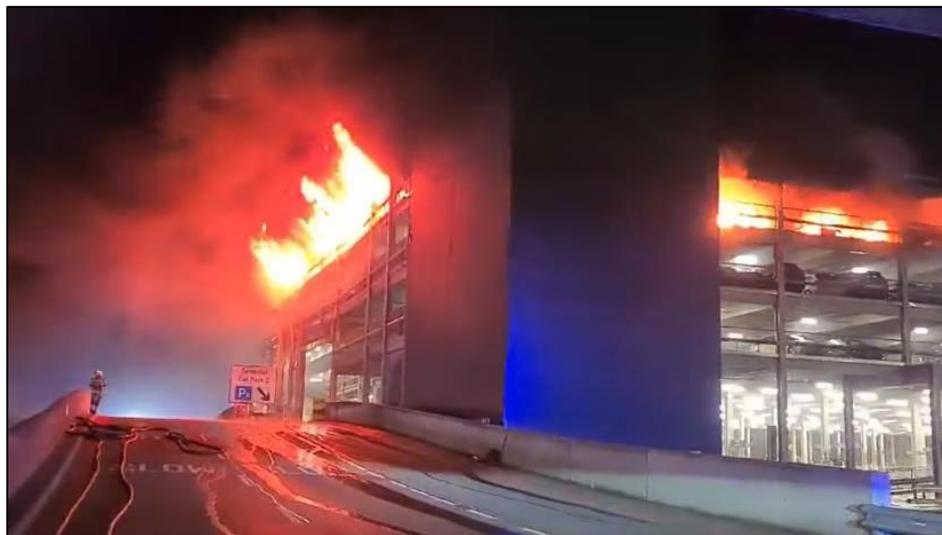
According to a news article [19], the fire started on level 3 of the parking garage. Initial reporting has indicated that the fire originated in a diesel-powered vehicle, possibly a Range Rover. There was an arrest following this incident, but news reports indicate that it is believed the arrest is just a precaution and that the initiation of the fire is believed to be accidental. It is unclear if the individual that was arrested is the owner of the initiating vehicle. A photo of the fire well after its ignition showing considerable fire involvement of an entire level of the parking garage is shown as Figure 24.

Figure 24. Luton airport parking garage fire (source: ITV News [20])

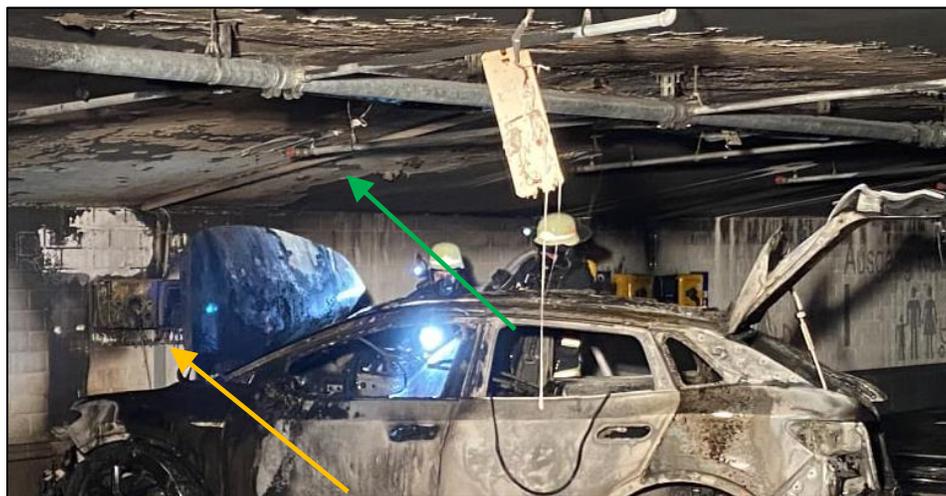
Figure 27. Magnified view of photograph of Marienplatz parking garage originating vehicle and surrounding fire scene. (Source: Feuerwehr Ravensburg). Annotations added by authors.

As can be seen in Figure 27, the sprinkler was positioned over the originating vehicle. It is unclear whether this is optimal or near-optimal sprinkler placement or not. Nevertheless, with

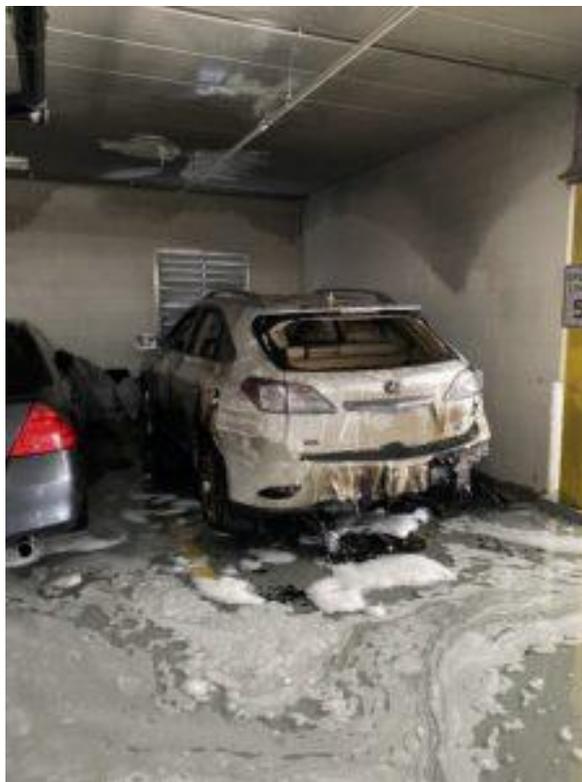
Figure 29. Des Plaines, Illinois parking garage fire (source: Festenstein, 2023 cross-referenced to Des Plaines Fire Department)

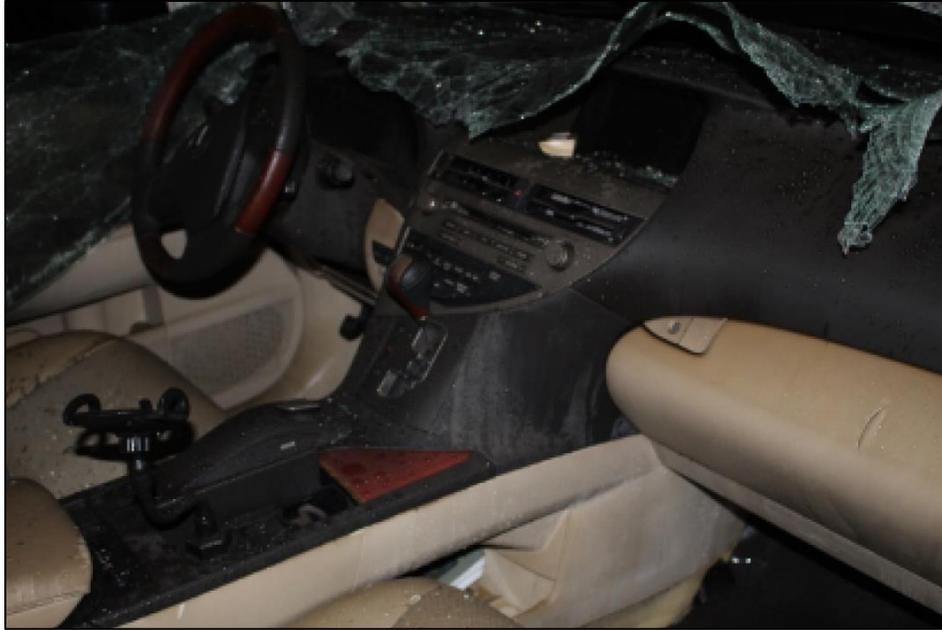
Per the NFIRS report, the Fire Department was first dispatched at 8:17 am and the first arriving units arrived at 8:21 am. The Fire Department had trouble accessing the parking garage due to a non-functioning overhead door. Upon entry, they encountered little to no visibility due to the smoke in the garage. Ultimately, they found the burning vehicle and observed heaviest burning underneath the vehicle on the driver's side and rear of the vehicle. The Fire Department suppressed the fire, and noted that re-ignition occurred multiple times after stopping water application. Ultimately, the Fire Department used a hydraulic tool to open the hood of the car and extinguished an engine compartment fire at which point the fire did not re-ignite. Investigation after the fire indicated that the fire damage was heaviest in the engine compartment and at the rear bumper. The fire did not spread to the passenger compartment, as seen in Figure 30. Interviews with the property manager by Fire Department investigative personnel indicated that this vehicle may have leaked liquid fuel at some point in the days or weeks prior to the fire. This liquid fuel was reportedly cleaned up, but this behavior may indicate a preexisting issue with the vehicle.

Figure 30. Interior passenger compartment of origin vehicle in Des Plaines, Illinois parking garage fire (source: Des Plaines Fire Department)

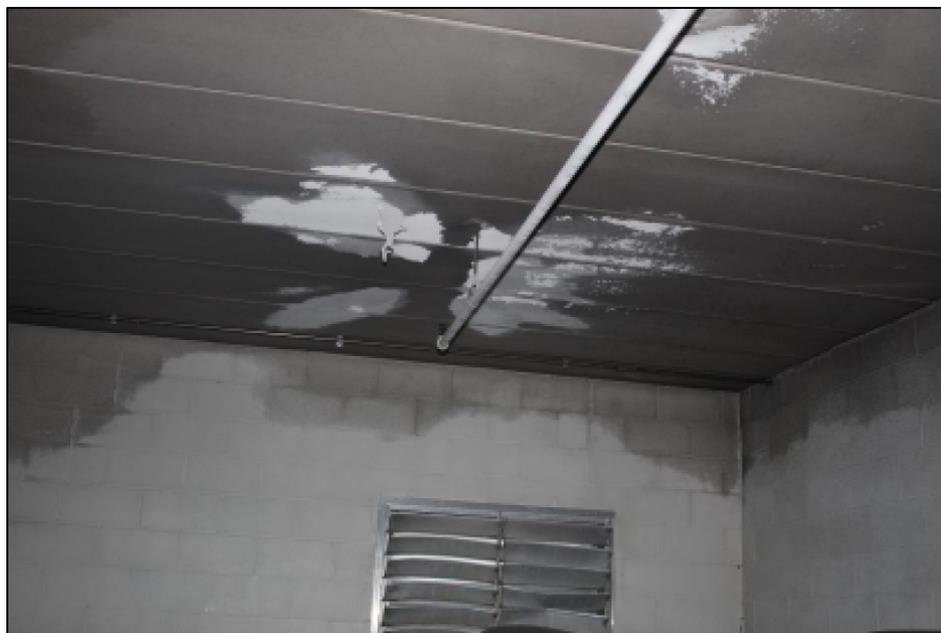
In this case, the sprinkler system controlled the fire until Fire Department intervention. Whether it was one sprinkler head or two, while the fire appears to have been shielded and not extinguished by the sprinkler system, the fire had not involved the passenger compartment where a significant amount of additional fuel would have been available. The fire also did not spread to the neighboring vehicle, which appears to be only 2-3 feet away (see Figure 29). This certainly is indicative of a successful sprinkler intervention in the fire by limiting the amount of fuel involved and preventing vehicle-to-vehicle fire spread, despite the presence of both a lithium-ion battery and liquid gasoline. This successful performance would be attributable to an OH1 designed system, though with only one or two sprinklers activating, more water was likely delivered than the OH1 design density since the whole design remote area of sprinklers was likely not activated. Additionally, photographs of the fire scene do not seem to support any significant spalling or other structural issues after the fire. In fact, it appears only to be some minor heat damage and perhaps scorched paint on the ceiling, as shown in Figure 31.

Figure 31. Ceiling above origin vehicle in Des Plaines, Illinois parking garage fire (source: Des Plaines Fire Department).
