CORROSION IN AUTOMATIC SPRINKLER SYSTEMS

This data sheet provides recommendations that are intended to address the prevention and control of corrosion in automatic sprinkler system piping.

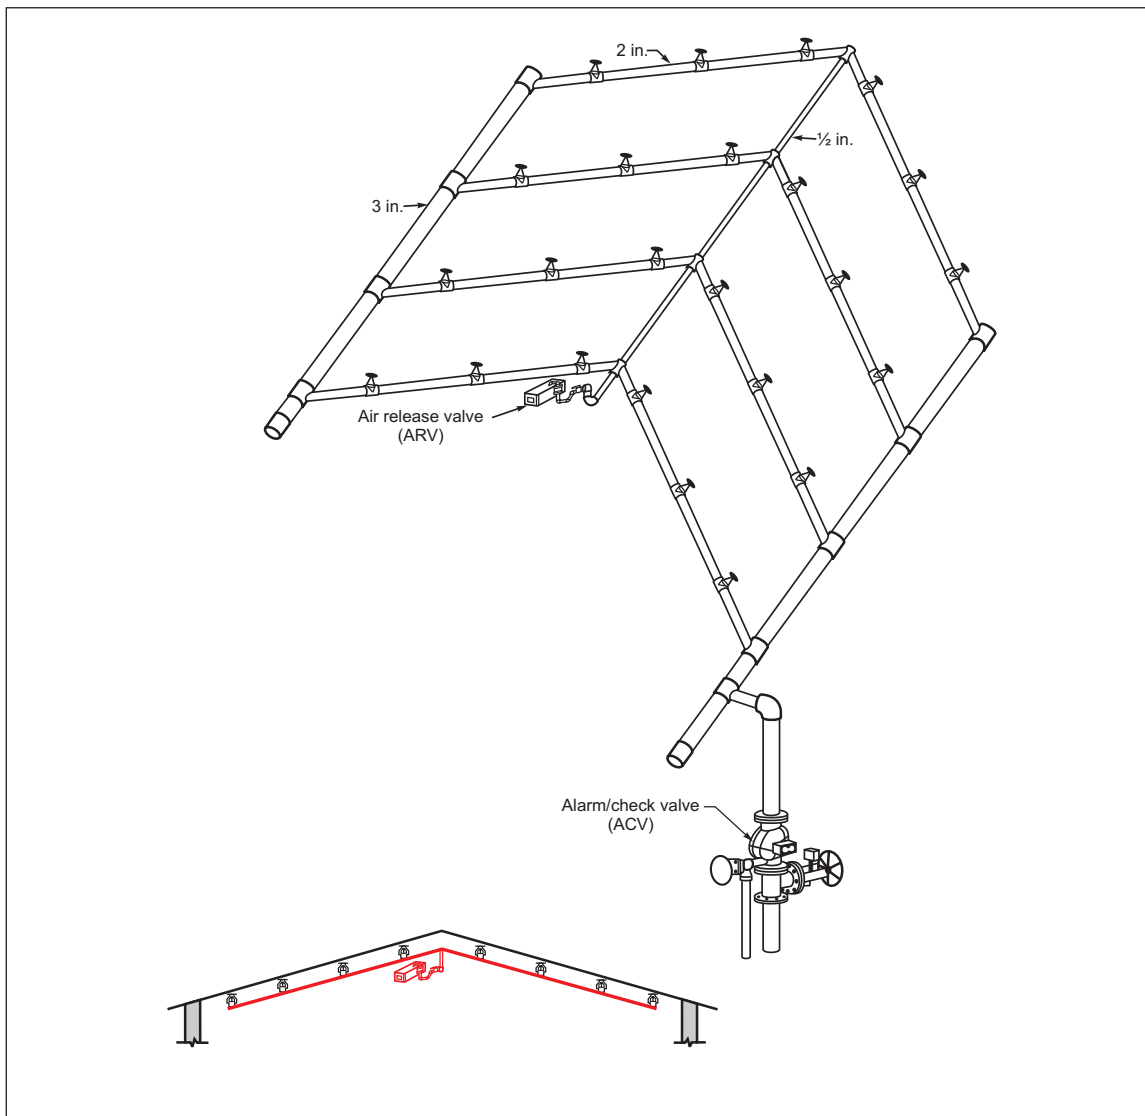
Fig. 1. Example of wet sprinkler piping arranged with an automatic air-release valve

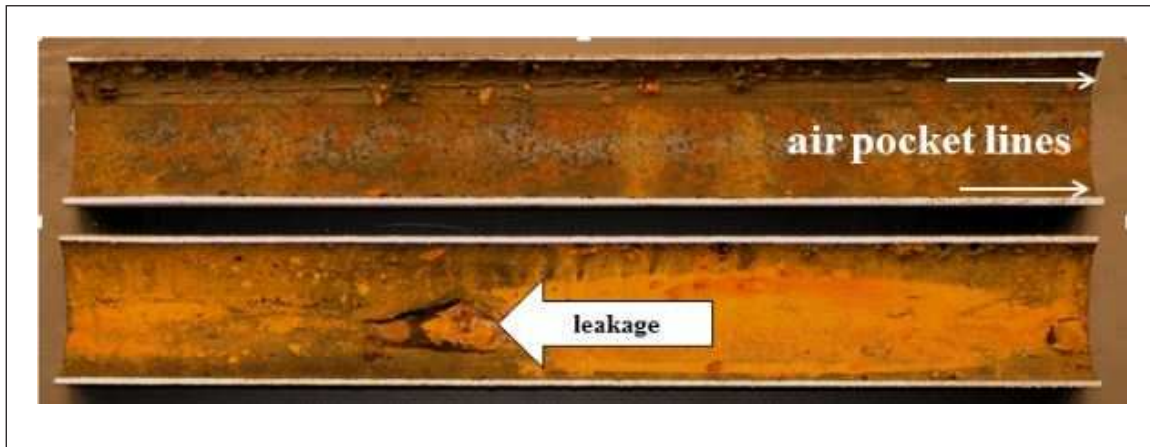
Figure 5 shows the section of a pipe in which the air gap filled approximately 40% of the volume in a wet pipe system, providing the oxygen source for steel pipe corrosion. The through-wall leakage site is indicated and the two parallel lines point to the air pocket boundary in the pipe. Note the significant tuberculation, corrosion, and deposit buildup in the bottom half of the pipe. The arrow points to a large tubercle, beneath which was the site of the leakage.

Fig. 5. Leakage section of a pipe where the air gap filled approximately 40% of the volume in a wet-pipe system

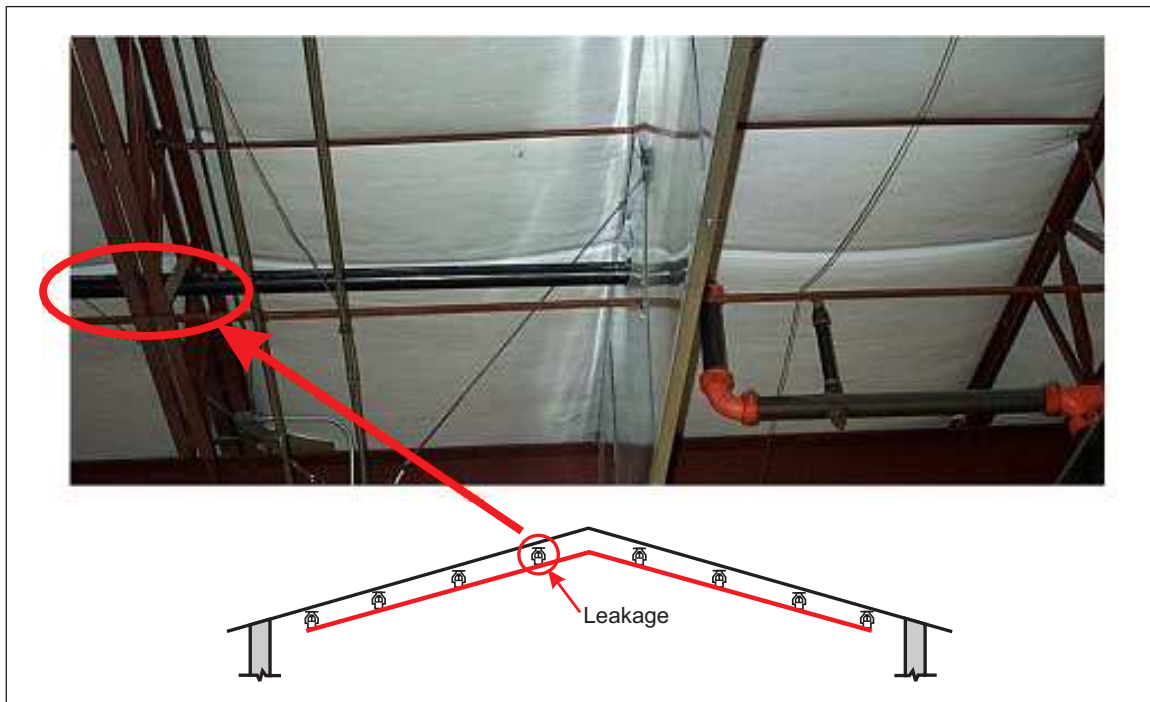
Figure 6 shows leakage sites of a wet pipe system due to trapped air. The leakage sites were at the left in the picture and near the roof bar joist as indicated. They were 10-15 ft to the left of the highest point in the system.

Fig. 6. Leakage sites of a wet pipe system due to trapped air

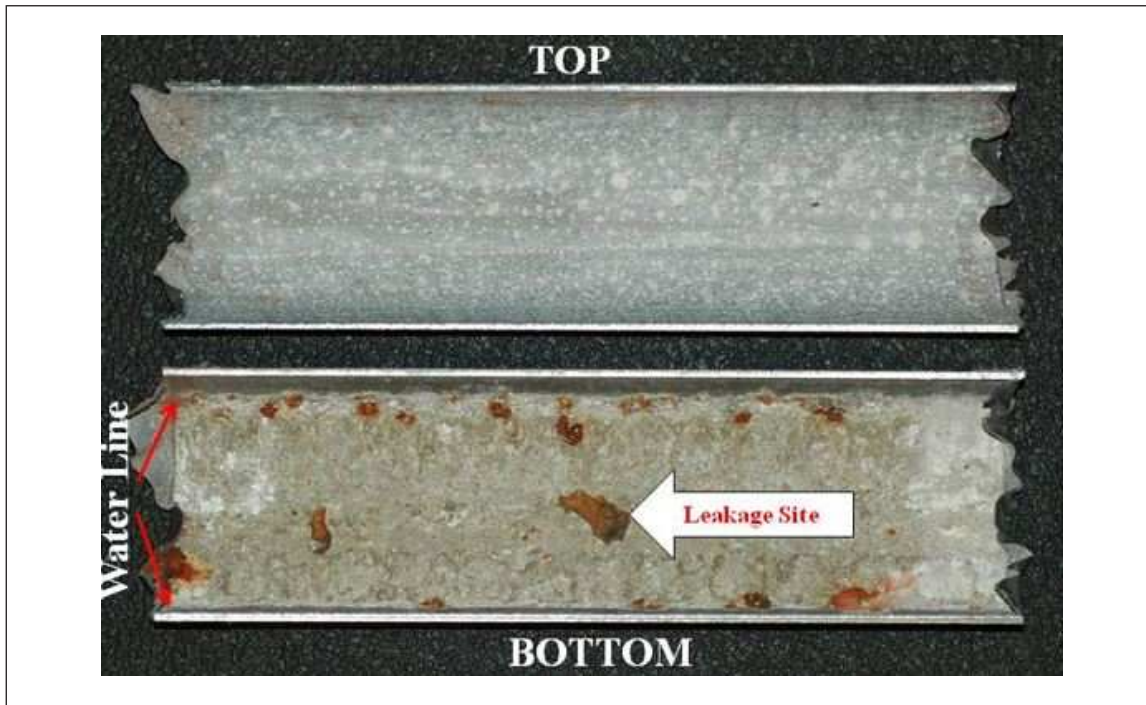
Figure 10 shows NPS 4 galvanized steel pipe (4.5 in. [11.4 cm] OD) with through-wall leakage. Residual water filled about 40% of the pipe's volume in service. Under the waterline, white rust (zinc corrosion) and well over a dozen reddish-brown tubercles of various sizes are evident on the bottom half of the pipe. The corrosion remains localized. The top half of the pipe is free of corrosion while the bottom half has significant corrosion.

Fig. 10. NPS 4 galvanized steel pipe (4.5 in. [11.4 cm] OD) with through-wall leakage

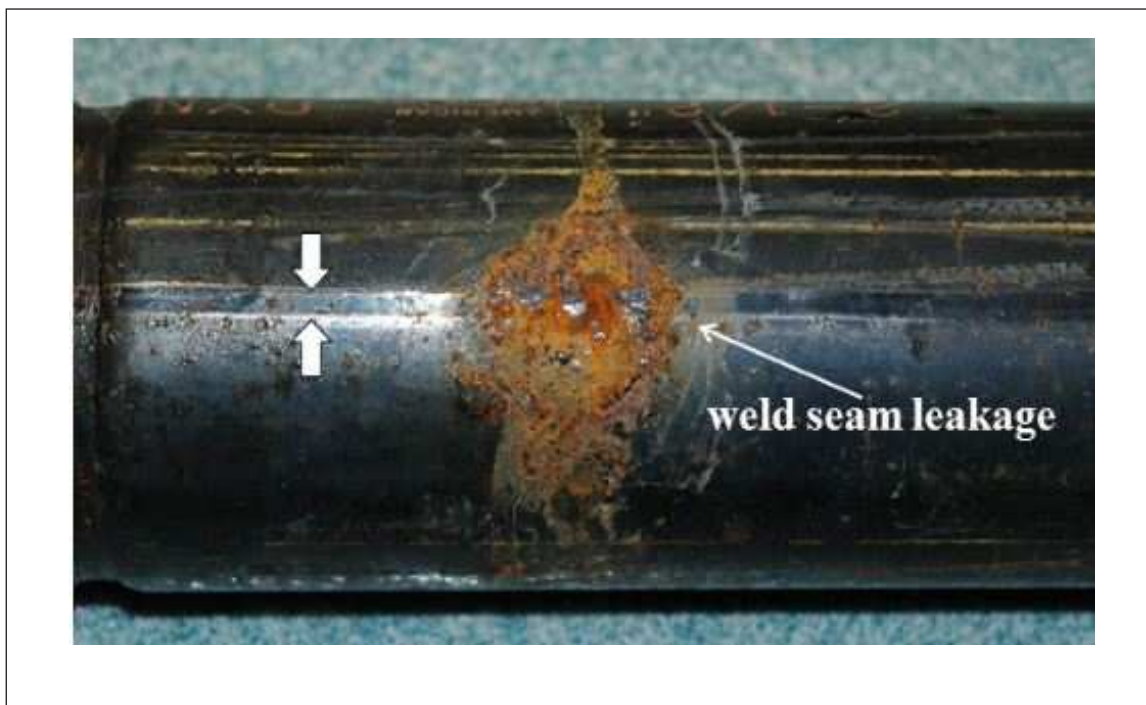
Figures 11a and 11b show leakage on an NPS 2½ steel sprinkler pipe in a wet pipe system. The weld seam leakage site and the location of the weld seam are indicated by arrows in Fig. 11b. Leakage on an NPS 2½ steel sprinkler pipe in a wet pipe system after removal of corrosion products; preferential attack surrounding the weld seam is severe

Fig. 11a. Leakage on an NPS 2½ steel sprinkler pipe in a wet pipe system; arrows indicate the weld seam leakage site and the location of the weld seam

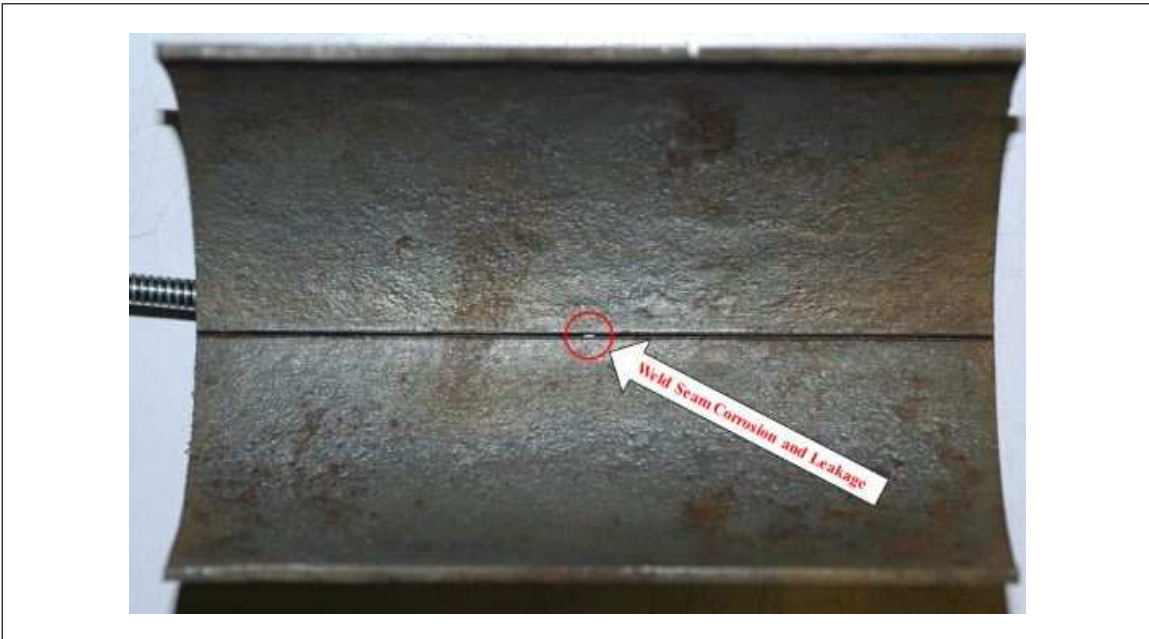
Figure 12 shows an example of preferential grooving corrosion on a pipe weld seam with a .04 in. (1 mm) pinhole leak in a wet-pipe system, after removing corrosion products inside an NPS 3 pipe.

Fig. 12. Preferential grooving corrosion on a pipe weld seam with a .04 in. (1 mm) pinhole leak in a wet pipe system, after removing corrosion products inside an NPS 3 pipe
