BRE Global Client Report

Fire experiments on mobility scooters protected by sprinklers

Prepared for: Lewisham Homes
Date: 5 May 2016
Report Number: P102574-1000, Issue 3

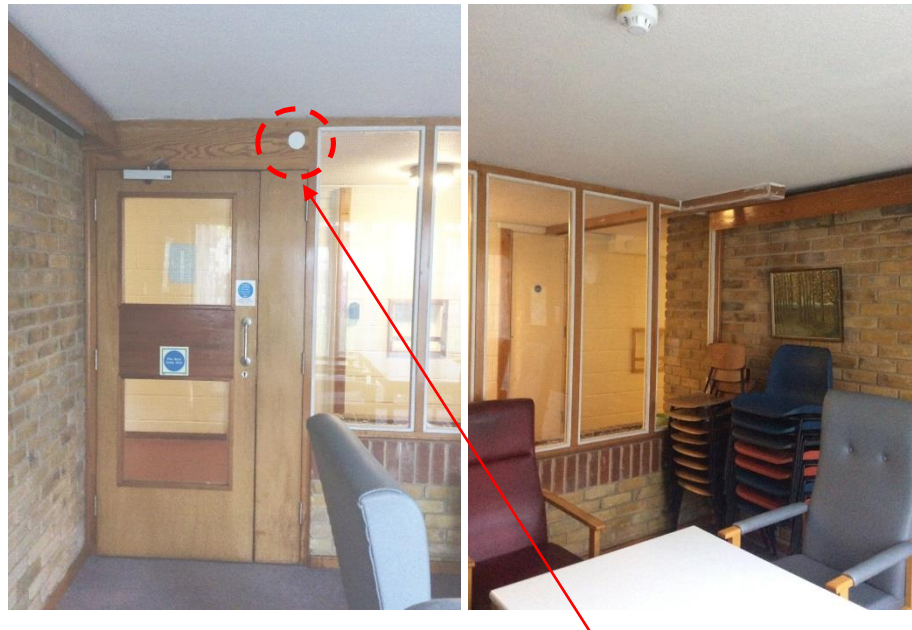
Figure 2 – Photos from Waverley Court. Left image showing the location of the concealed sprinkler head

BRE was supplied with the layout of rooms with the information on type and number of installed sprinkler heads as Figure 1. Figure 2 shows photos taken by the client in one of the locations (Waverley Court) showing position of the concealed sidewall sprinkler head.

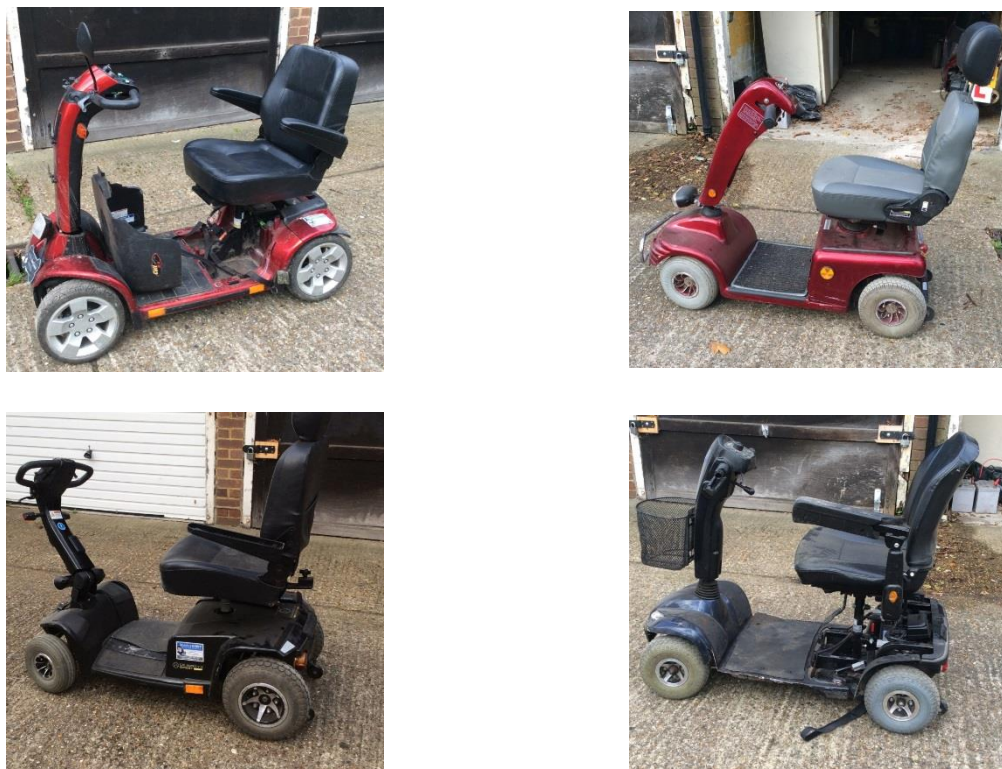
Figure 3 – The mobility scooters which were supplied by the client for the fire experiments.

The client supplied four different scooters (see Figure 3) to BRE Global on 1st March 2016 and asked that three should be used together in one experiment and one should be used in a second experiment.

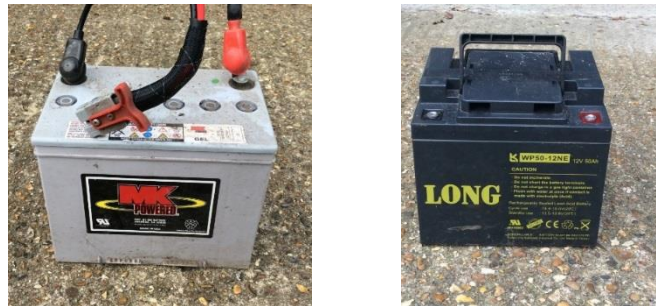
Figure 4 – Lead-acid batteries installed in the scooters.

The client also wished to assess one scooter equipped with a lithium-ion battery and three other scooters with typical lead-acid batteries (shown in Figure 4). This information was important as Li-Ion batteries can undergo thermal runaway and release flammable gases and consequently create more severe conditions [1].

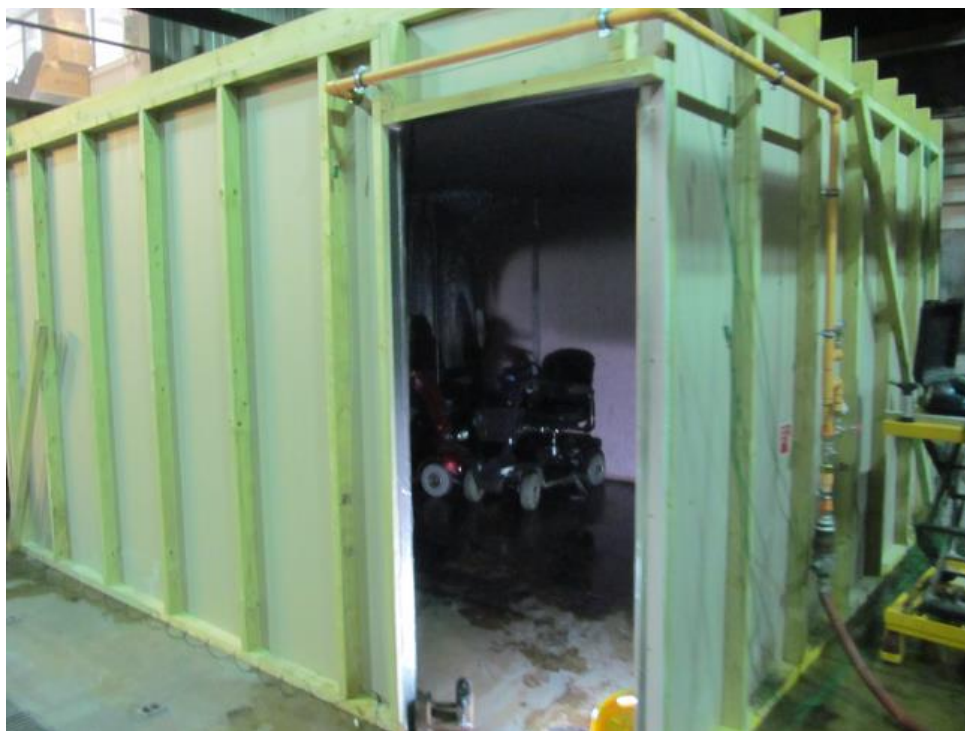
Figure 5 – Photo showing experimental compartment

Therefore the client agreed that the experimental compartment would have the dimension of 4 m x 3.55 m with a ceiling height of 2.3 m which is identical with the room in the Waverley Court, but constructed in a simpler manner, i.e. no glazing panels and bricked walls were used. A door opening of 2 m x 0.82 m was included (without a door). The compartment was lined with a single layer of 15 mm plasterboard fixed from the internal side to timber studs.

A single concealed sidewall sprinkler head was located at 2.15 m height and installed by the client's subcontractor, Domestic Sprinklers. The sprinkler head was installed from a CPVC sprinkler pipe with 6.5 bar static pressure and 200 litre/min flow rate at 2.0 bar working pressure.

The experimental compartment was erected in BRE Burn Hall facility as shown in Figure 5 and two experiments were carried out.

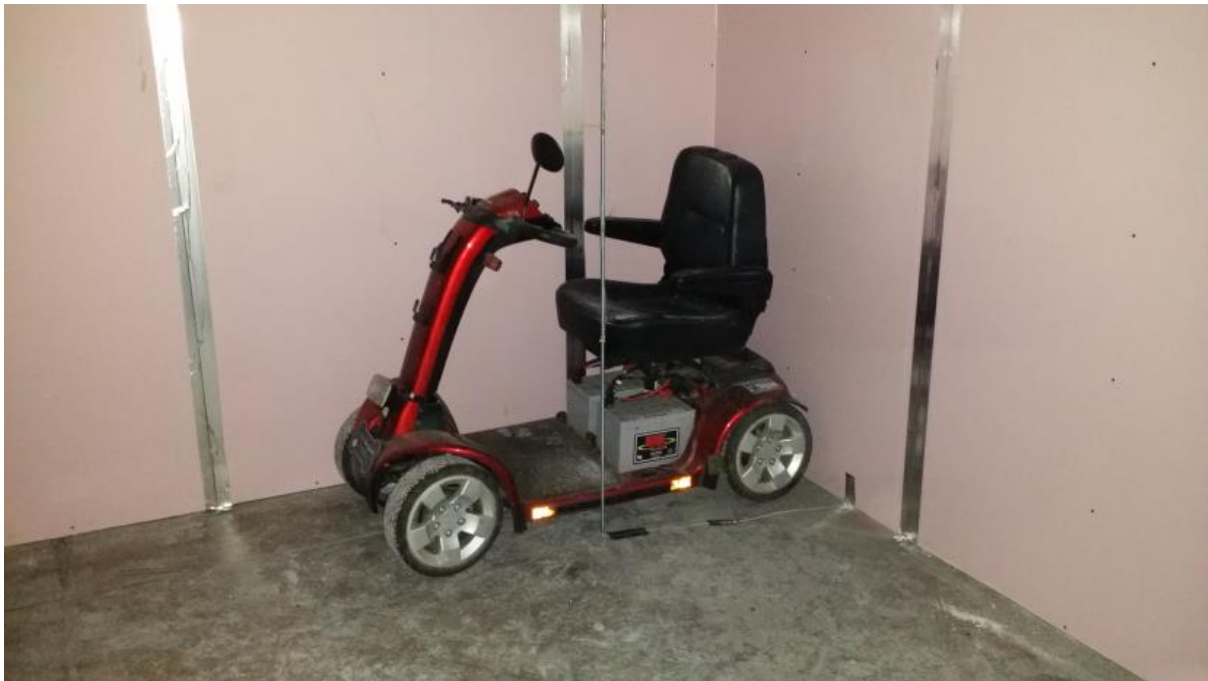
Figure 7 – Photo of a mobility scooter located at the corner of the compartment, Experiment #1

In the first experiment (Experiment #1), a single mobility scooter fitted with lead acid battery was located at the corner of the compartment as shown in Figure 6 and Figure 7.

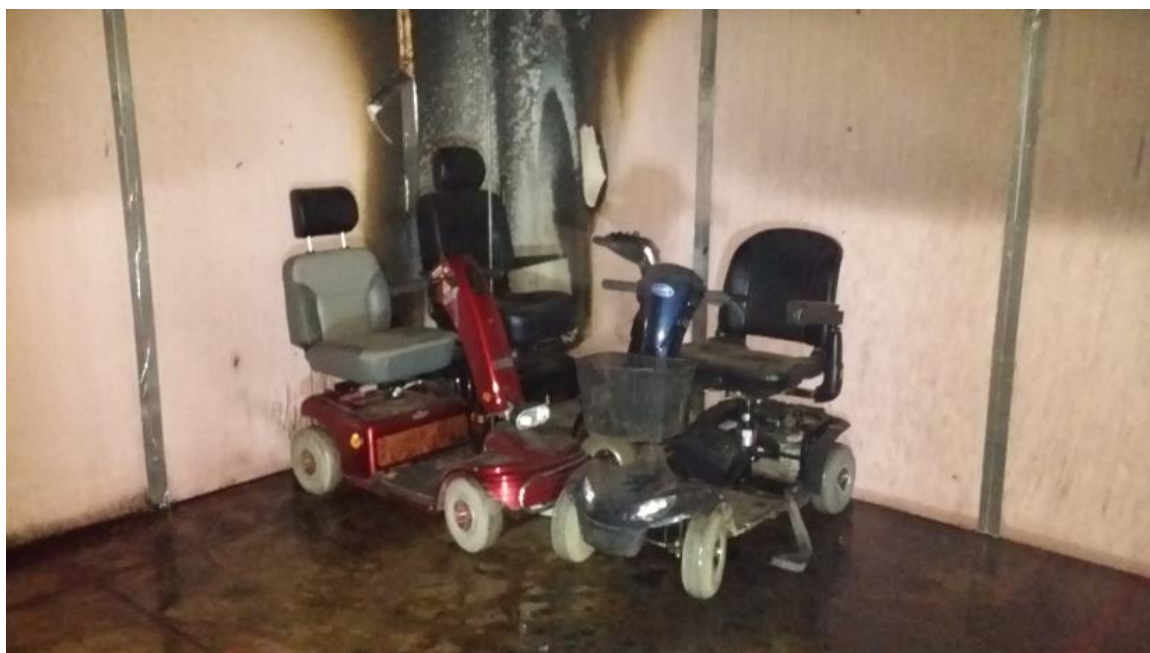
Figure 9 – Photo of mobility scooters located at the corner of the compartment, Experiment #2
(Note damage to the compartment from Experiment #1)

In the second experiment (Experiment #2), three scooters were parked inside the experimental compartment with one parked to provide a shielding effect, i.e. parked next to the scooter being the source of fire to create more challenging conditions as shown in Figure 8 and Figure 9. In this experiment, one scooter was fitted with a Li-Ion battery as a fire source.

For Experiment #2, the fire was started in a scooter (fitted with a Li-Ion battery) parked in left hand corner furthest away from the sprinkler head. Other scooters were parked as shown in the figure above as close to each other as expected in reality. The sprinkler head (and cover) was replaced with a new one after the first experiment as shown in Figure 10.

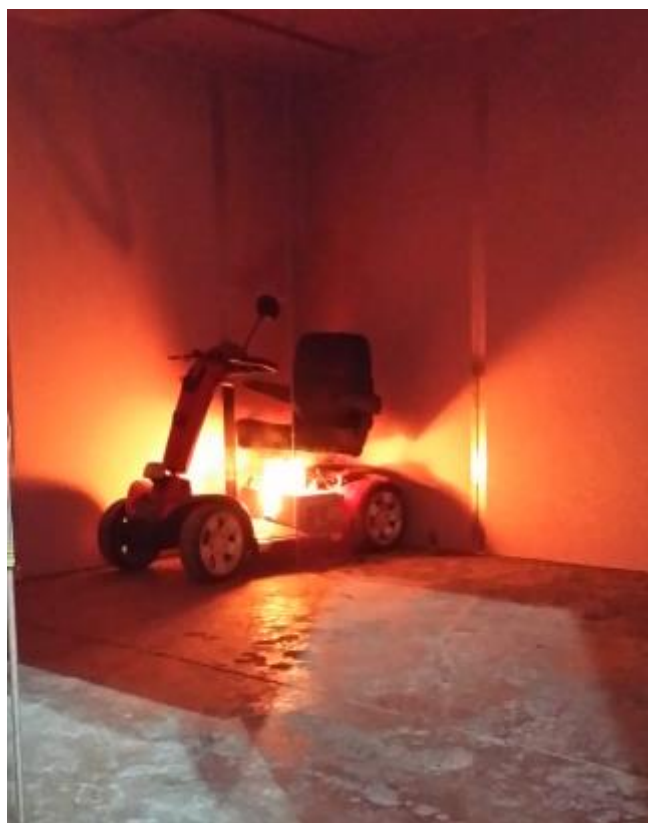
Figure 12 – Ignition of a mobility scooter in Experiment #1

Experiment #1 took place from 09:45. The fire was initiated close to the battery compartment of a mobility scooter equipped with a lead acid battery as shown in Figure 12.

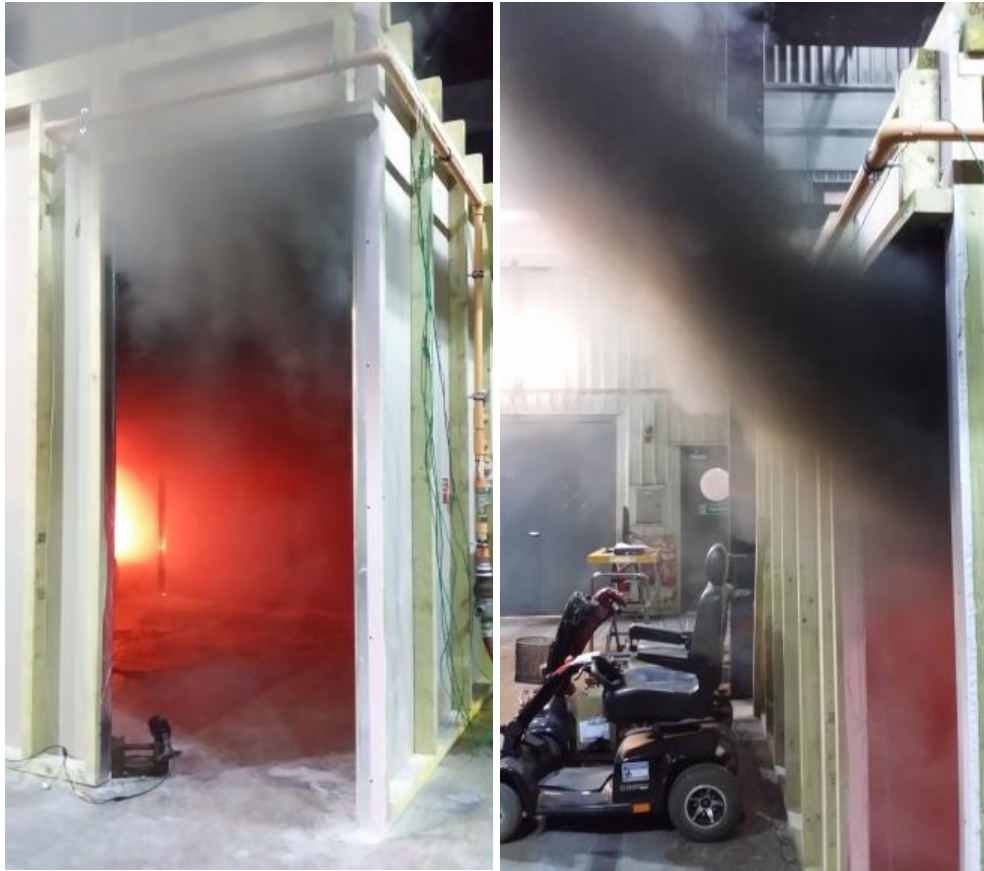
Figure 13 – Black smoke coming out from compartment, Experiment #1
(Left: front view, right: side view)

Approximately two minutes after ignition, black smoke started to come out from the compartment as shown in Figure 13 and at about 5 minutes from ignition the flame spread to the seat of the mobility scooter as shown in Figure 14. At about 6 minutes 25 seconds, the sprinkler activated. After the sprinkler started to suppress the fire, thick smoke was produced and no useful visible observation could be made as shown in Figure 15.

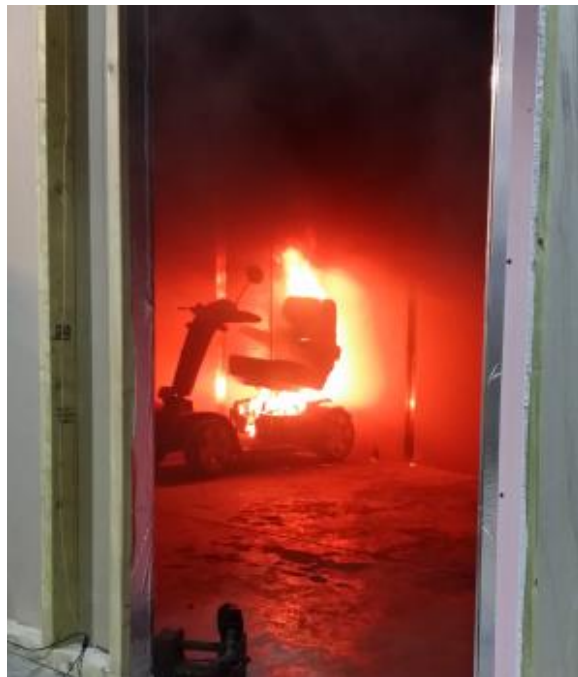
Figure 14 – Flame spread to mobility scooter seat, Experiment #1

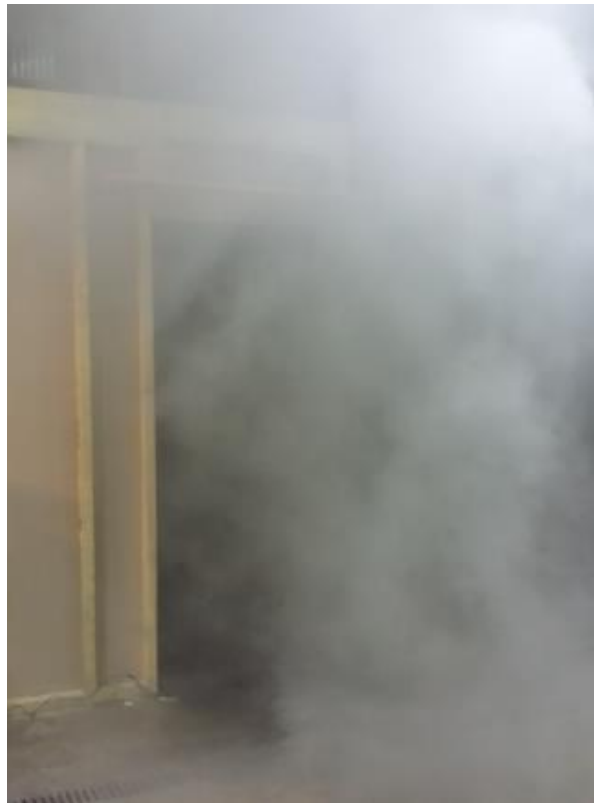
Figure 15 – Thick smoke coming out from the compartment after sprinkler activation, Experiment #1

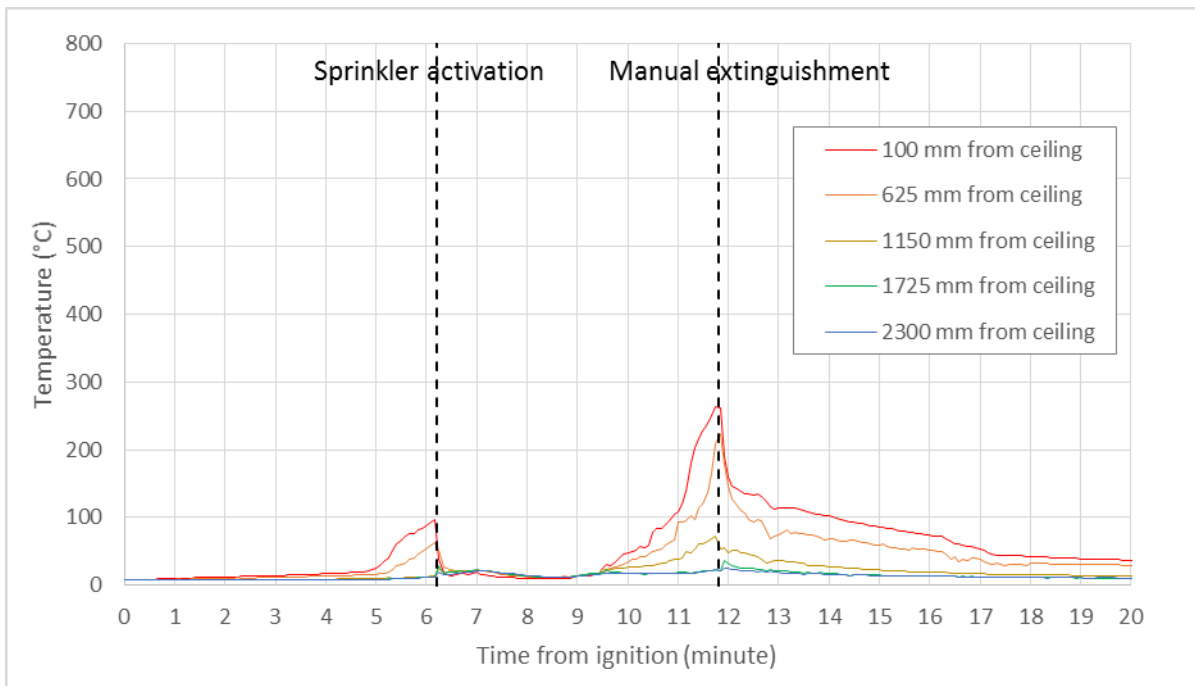
Figure 16 – Temperature data of thermocouple tree #1, Experiment #1

Figure 17 – Temperature data of thermocouple tree #2, Experiment #1

Figure 18 – Temperature data of thermocouple tree #3, Experiment #1

At the client's request, the sprinkler was turned off at about 3 minutes after activation to see if the sprinkler had suppressed the fire and if not, whether the fire developed again. The temperature started to rise again reaching up to 780 °C and the fire had to be manually extinguished for health and safety reasons due to excessive smoke in the laboratory.

Figures 16 to 18 present temperature data measured from the three thermocouple trees. The first temperature drop can be observed at about 6.2 minutes from ignition, then re-rise of the temperature from about 9 minutes when the sprinkler was turned off. The temperature at 100 mm from ceiling from the thermocouple tree #3 (next to sprinkler head) showed 63 °C at the point of sprinkler activation.

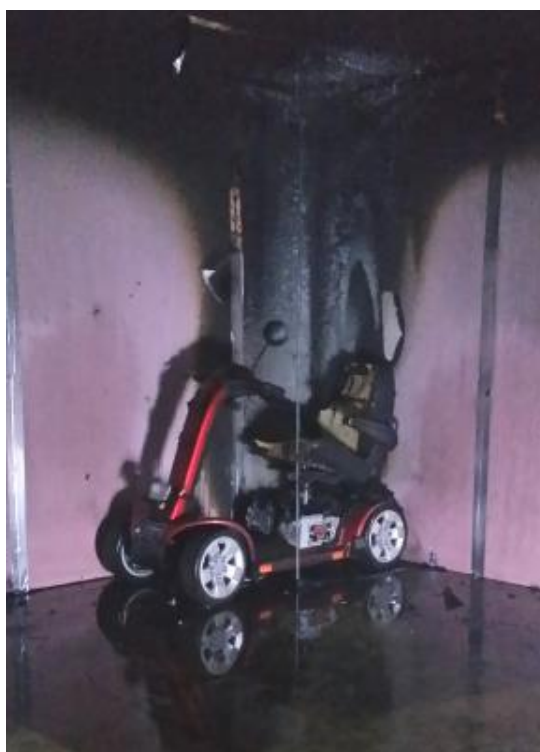
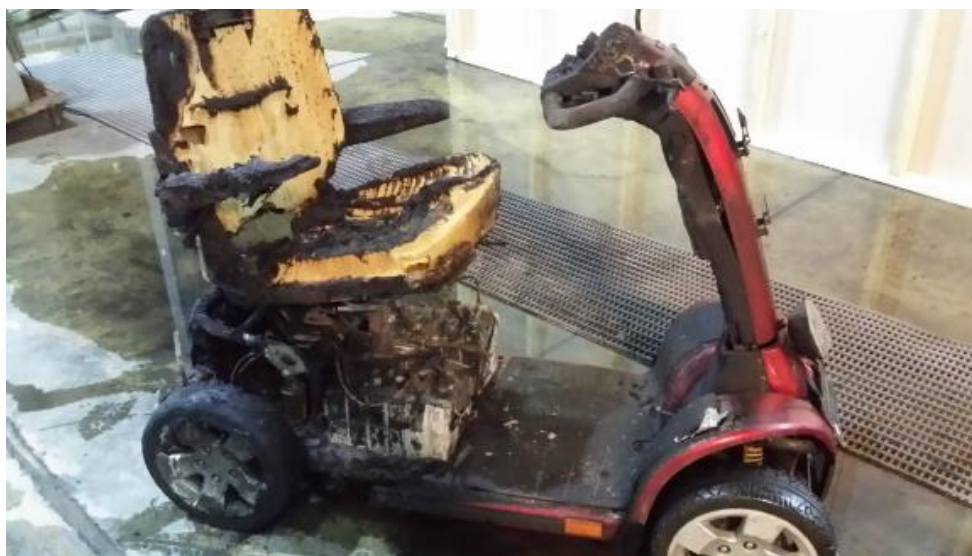
Figure 19 – Mobility scooter in the compartment after Experiment #1

Figure 20 – Photo showing damage to mobility scooter after Experiment #1

Figures 19 and 20 below show the mobility scooter after Experiment #1. Most of the part of the seat which was made of foam was burnt, however, the remaining body of the mobility scooter was left intact. The lead acid batteries were partially burnt but there was no sign of leakage or explosion.

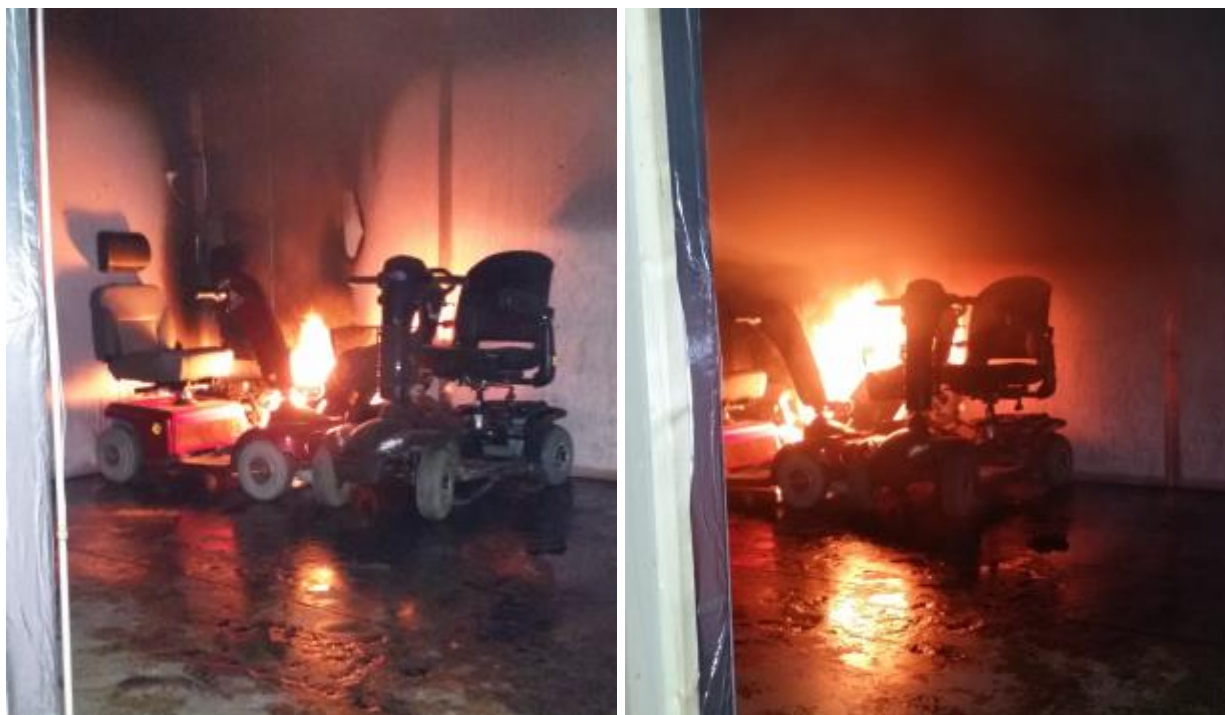
Figure 21 – Ignition of a mobility scooter in Experiment #2
(Left: immediately after ignition, right: approximately 2 minutes after ignition)

Experiment #2 took place from 11:00. The sprinkler head was replaced with a new head and three mobility scooters were positioned in place as shown in Figure 9. The fire was initiated close to the Li-Ion battery compartment of the mobility scooter parked at the corner of the compartment as shown in Figure 21.

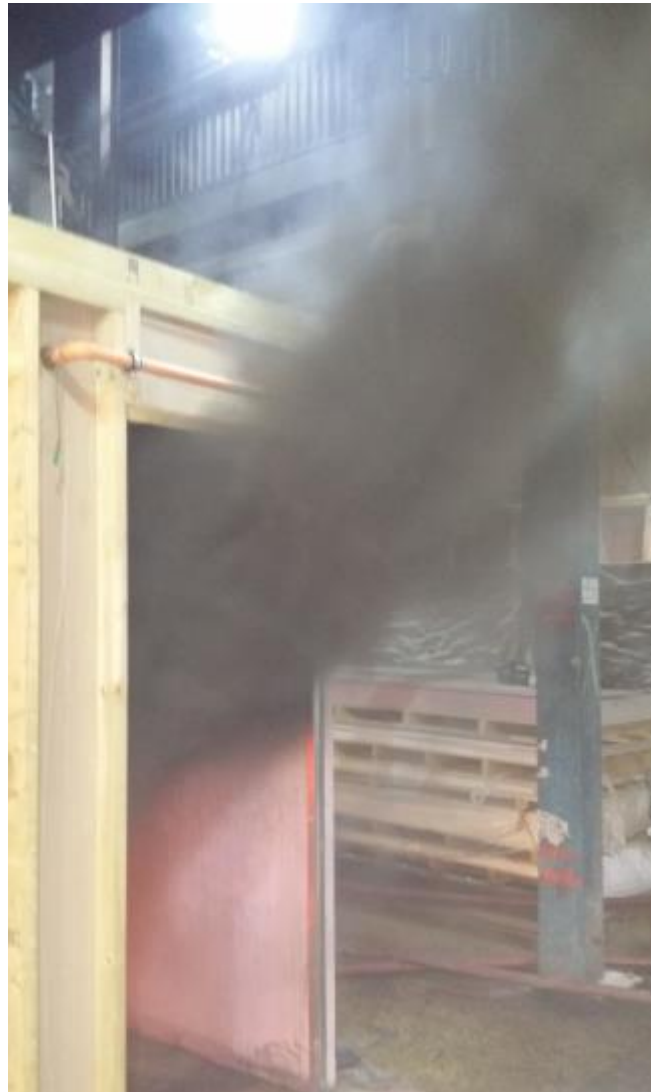
Figure 22 – Thick smoke coming out from the compartment before sprinkler activation, Experiment #2

Figure 22 shows the thick smoke coming out from the compartment just before sprinkler activation.

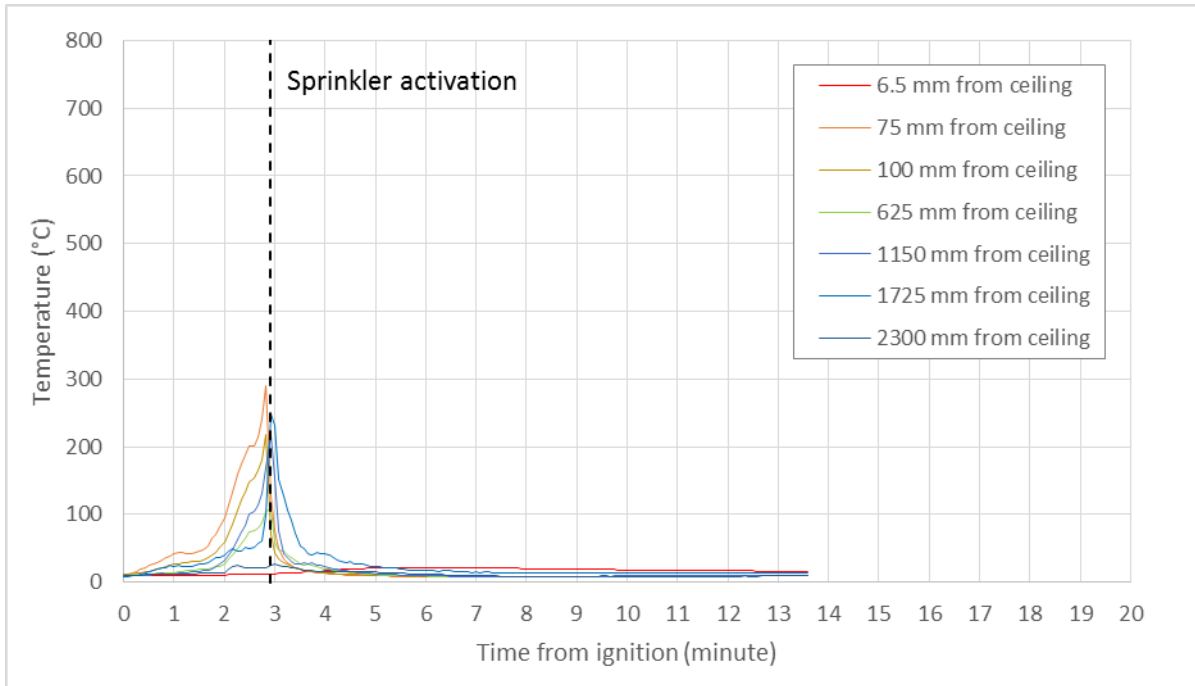
Figure 23 – Temperature data of thermocouple tree #1, Experiment #2

Figure 24 – Temperature data of thermocouple tree #2, Experiment #2

Figure 25 – Temperature data of thermocouple tree #3, Experiment #2

Figures 23 to 25 show the compartment temperature data measured from the thermocouple trees. Unlike Experiment #1, the temperature rose rapidly and at about 2 minutes 50 seconds, the temperature at 100 mm from ceiling at thermocouple tree #3 (close to sprinkler head) reached about 90 °C and the sprinkler activated. In this experiment, the sprinkler was left to operate for further 10 minutes and the experiment was then terminated since the fire appeared to be suppressed (possibly extinguished).

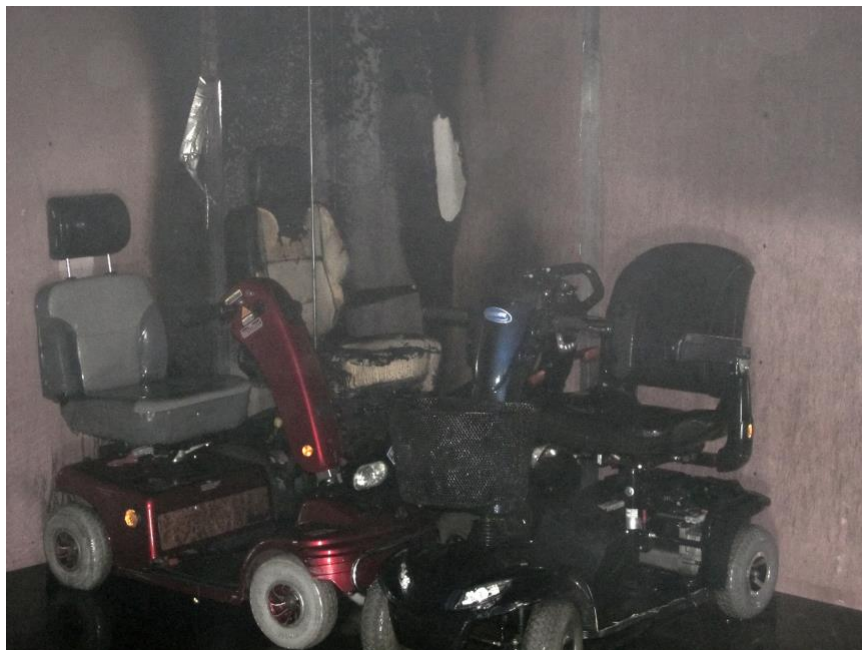
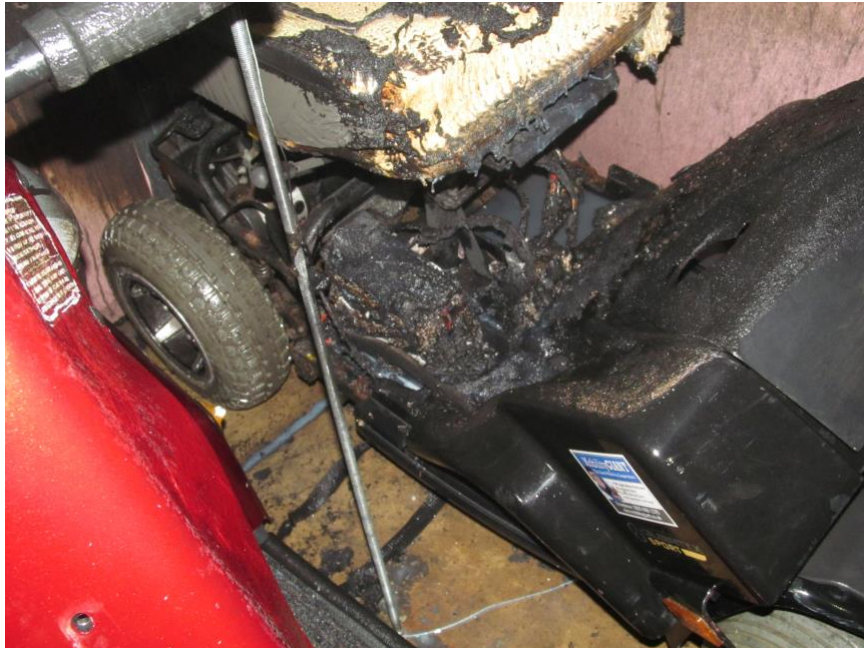
Figure 26 – Mobility scooters in the compartment after Experiment #2

Figure 27 – Photo showing damage on mobility scooter around Li-Ion battery after Experiment #2

Figures 26 and 27 show the damage to the mobility scooters after Experiment #2. Since the temperature in the compartment rose much more rapidly than Experiment #1, and thus resulting in relatively quicker sprinkler activation the flame spread from the battery compartment to the mobility scooter seat; however, it did not affect the adjacent mobility scooters.

The cover of the Li-Ion battery was heavily damaged, however, it appears that the flame did not penetrate the cover. Consequently the internal material was not affected and there was no explosion.
