RESEARCH FOUNDATION
RESEARCH FOR THE NFPA MISSION

Modern Vehicle Hazards in Parking Structures and Vehicle Carriers

Final Report by:

July 2020

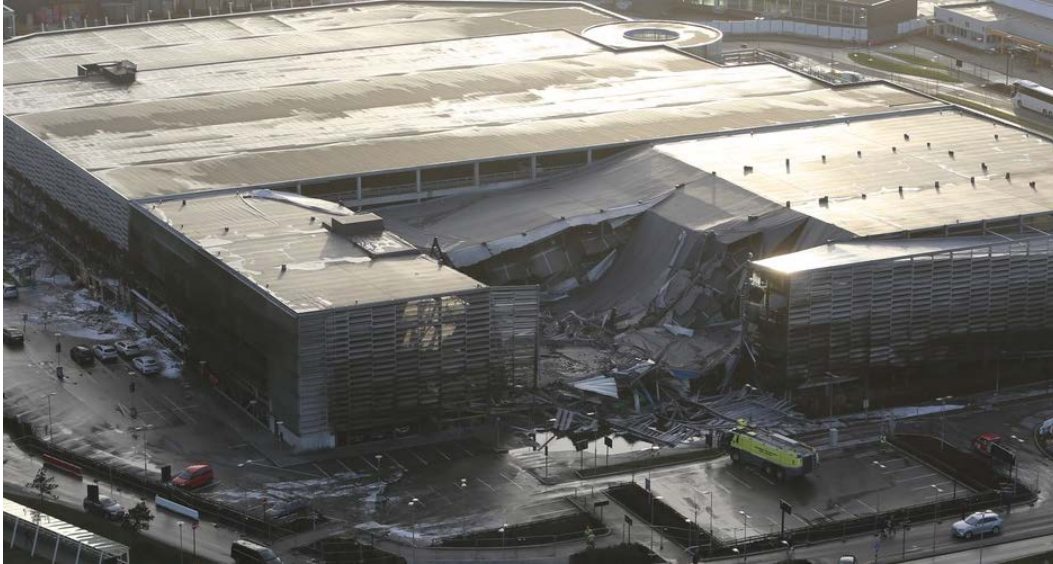
Figure 1 – Partially collapsed parking garage at Norway’s Stavanger Airport after fire in January, 2020.

Another fire with very extensive impact occurred on January 8th, 2020 in an open parking garage at Stavanger airport in Sola, Norway [The Local, 2020]. The fire is reported to have started in a 2006 diesel car (Opel Zafira) [Frafjord, 2020]. A similar model car is also reported to have started a fire in an Irish parking garage, and has been subject to a recall [English, 2019]. The incident vehicle at Sola was a 2nd generation with left side steering, while the UK recall applied to 1st generation vehicles with right side steering [Karlsen, 2020]. The Norway fire destroyed 200-300 vehicles inside the building, with a further 1,300 vehicles trapped with some degree of heat and smoke damage, and part of the five-story structure collapsed (see Figure 1). The owner of the originating vehicle stated that he attempted to start it, saw smoke coming from the engine compartment, and soon after flames. News articles about the incident report that it still took the fire department approximately 19 minutes from ignition until first units arrived [Klingenberg and Ramsdal, 2020], and that the first fire fighters claimed to have seen as many as 10 vehicles burning on arrival, though this has not been confirmed. As the airport firefighters are not able to respond to non-aircraft fires while the airport is operating, the closest responding fire fighters had a travel time of up to 13 minutes (at normal driving speed).

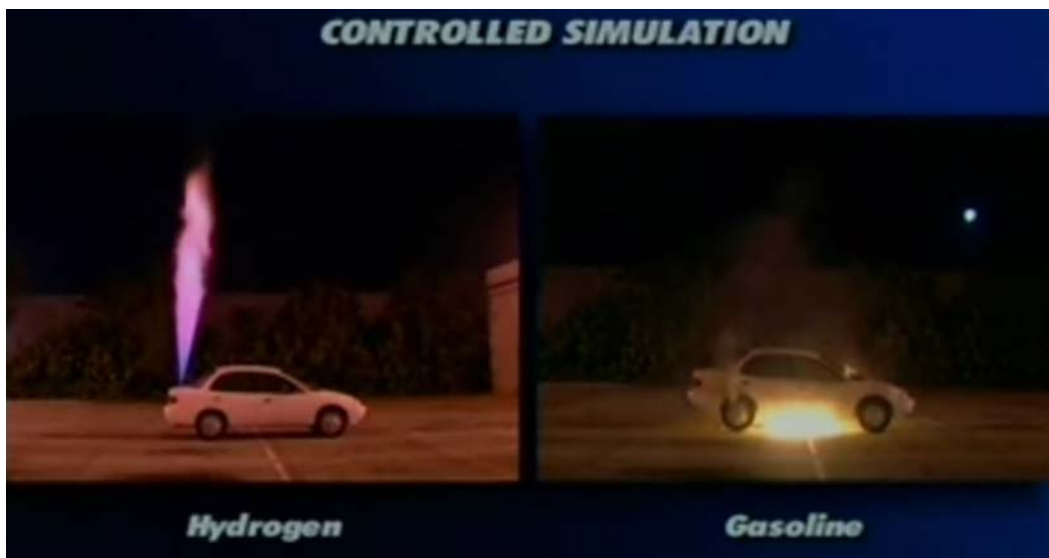
Figure 3 – Test demonstrating the difference between hydrogen and gasoline fires.

The main hazard from a hydrogen fuel cell vehicle is rupture of the hydrogen storage tank and release of the gas. As hydrogen is much lighter than air, leaking or burning hydrogen would quickly travel upwards in a column, as opposed to a gasoline-fueled car where the spilled fuel gathers underneath the car, as shown in the test in Figure 3 [Greenway energy, 2009]

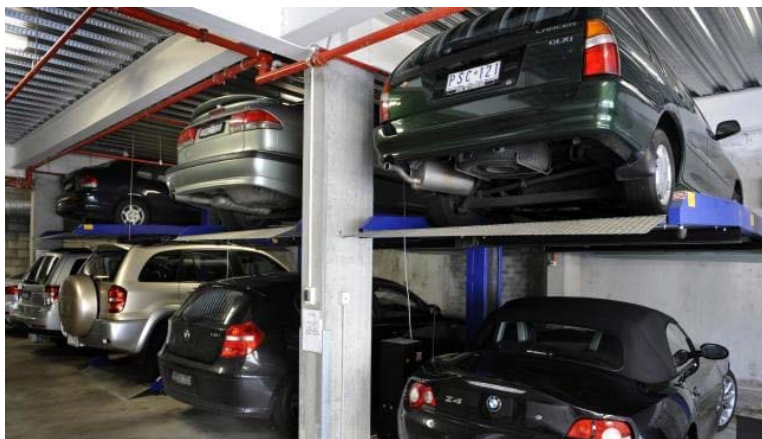
Figure 4 – Example of car stacker system.

Vehicle stacking systems and similar methods for more dense space usage pack large vehicle fire loads into smaller areas and to greater heights. An example is shown in Figure 4.

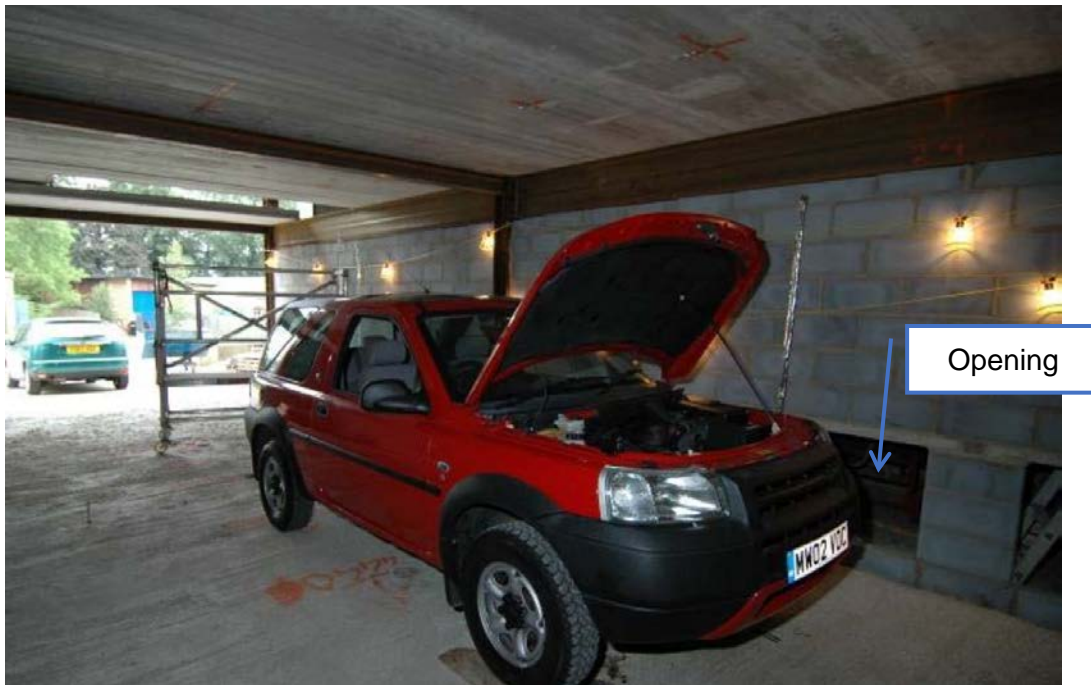
Figure 7 –Configuration of openings in BRE test [BRE, 2010].

A test series by BRE involved several multi-vehicle, full car fires in a parking garage mockup [BRE, 2010]. The tests found that with the second vehicle involved, the ceiling temperatures reached 1100°C, and a third car that was separated from the two others by an empty parking spot quickly ignited. The BRE test series involved a "car park enclosure", not a fully open garage. There was extensive ventilation around the vehicles, approximately 10 m², including a fully open wall. The NFPA 88A definition to consider a parking garage open is if interior walls are at least 20% open and uniformly distributed (section 5.5.2 and 5.5.5). In the BRE testing two of the sides were 25% open, but the third was solid, thus the testing space is not considered open per NFPA 88A. As shown in Figure 7, the openings were also low to the ground, only supplying air to the

fire, not venting hot gases as might be the case with a fully open configuration. Note that NFPA 88A does not have requirements for vertical placement of the openings but does state that openings shall be uniformly distributed.

Large beams and beam pockets are also common in multi-level parking garages which can trap hot gases. As Figure 7 shows the beams were relatively shallow in the garage mockup. The BRE tests can therefore be considered somewhere between an enclosed and fully open garage; the ventilation area is more than is expected in for example a small underground garage but venting of hot gases is more restricted than in a code-defined open configuration. How much the beam pockets contribute to trapping hot gases, and whether it's sufficient to ignite neighboring vehicles should also be established. This has been done for compartment fires (e.g. [Floyd, Gottuk and Mealy, 2008]), but it is not obvious that the dynamics of vehicle fires are the same. Vehicle fires are typically larger and faster growing, and the fuel package is larger and taller than in most compartment settings.

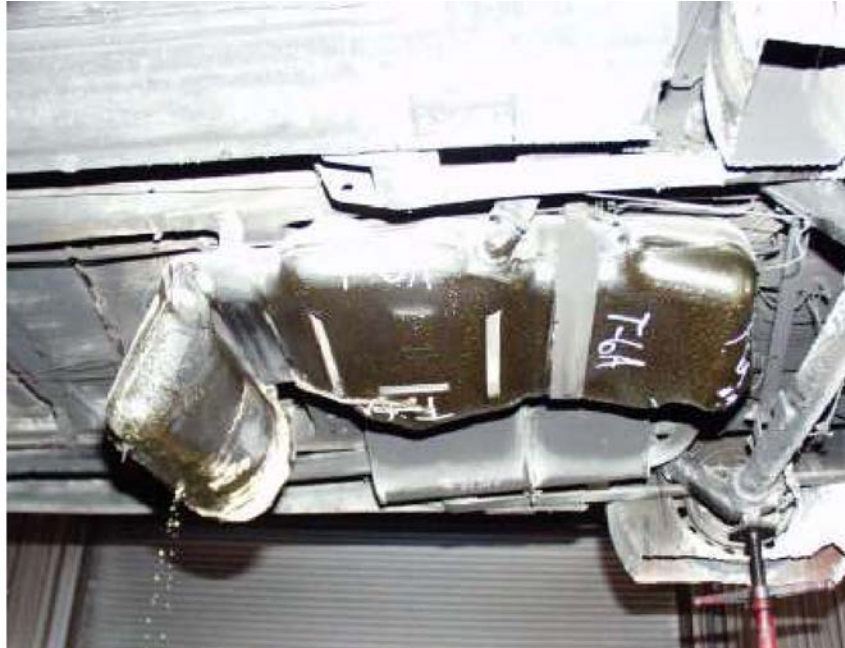
Figure 10 – Failing plastic fuel tank [Digges, 2003].

An important concern with plastic fuel tanks is the earlier release of fuel when exposed to an external flame as compared to a metal fuel tank. There are fire resistance requirements for plastic fuel tanks, specified in ECE R34.01, Annex 5 Section 5.0 “Resistance to Fire” [United Nations Economic Commission for Europe, 2012]. This standard requires a tank to show no leak of fuel after exposure to a direct flame for 2 minutes. The flame source is from a pool fire, typically using diesel or gasoline, that is slightly larger than the footprint of the tank, and a distance away equivalent to the height above the road as the tank would be installed in the vehicle. In the case of burning gasoline underneath a car from a full fuel tank release, the fire exposure could last much longer than the two minutes required in the tests. The concern with the two-minute requirement lies in the inability for firefighting personnel to arrive in that timeframe to extinguish a fire before the tank would melt and empty its contents. Even if the structure is sprinklered, the fire would be shielded which could slow down activation time and inhibit extinguishment. Based on this requirement a worst-case assumption could be that a plastic fuel tank would leak fuel after two minutes of direct fire exposure.

A series of tests performed by the Southwest Research Institute, and summarized by Digges [Machado, 2003; Digges, 2003], tested six different fuel tanks placed above fires that lasted past the two-minute requirement. The time when the tanks started to leak fuel was found to be from 10 seconds before the two-minute requirement, up to 2:36 min after the two minutes (i.e. after 1:50 to 4:36 minutes of fire exposure). It should be noted that the failure before the two minutes was performed on a new tank installed in a vehicle already damaged by fire, which could have led to increased ventilation. Per this testing, in a best-case scenario, a plastic fuel tank will leak fuel 4:36 min after exposed to an under-car fire. Only one metal tank was tested in this series. It was found to fail 4:22 min after the required time, i.e. 6:22 min after the fire started. The plastic fuel tank failed due to leaks and minimal venting whereas the metal fuel tank developed excessive pressures and vented large amounts of fuel.

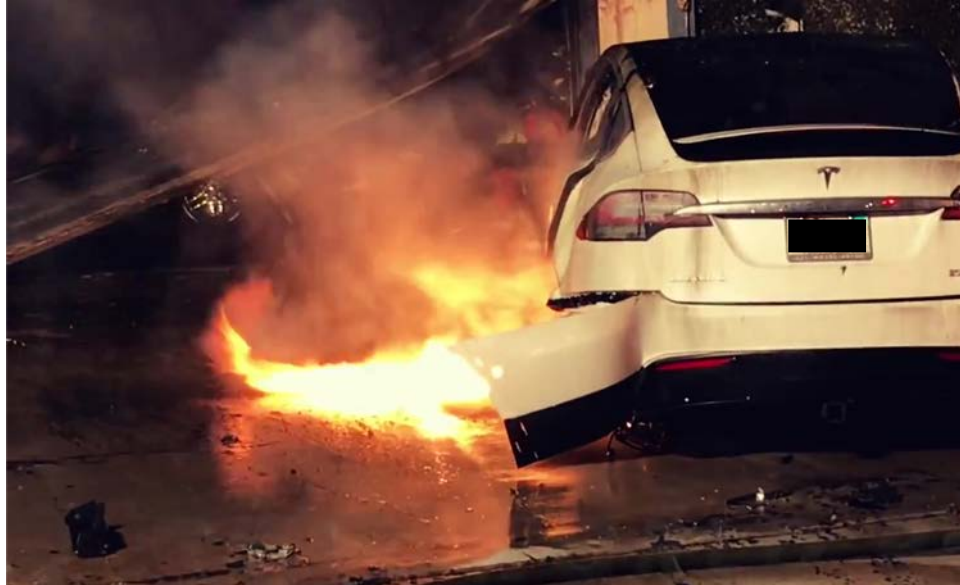
Figure 13 – Flame jet from Tesla model X battery electric car [NBC LA, 2017].

In 2017, an EV in California crashed into a private garage and caught fire [NBC LA, 2017]. The firefighters put the fire out and pulled the car out. A video shows flames jetting out from underneath the car, shown in Figure 13. In a different incident, an EV is reported to have reignited twice after a fatal collision [Reuters, 2018].

- Cars parked at unusual angles or in corners
- Cars at the edge of the sprinkler spray area
- Fires starting, and spreading, inside or under vehicles
- Strong wind through garages blowing away hot gases, delaying activation.
- Electric vehicle battery fires with jet near floor (see Figure 13)
- Stacker systems with more than two levels
- Lower water application density in stacker systems

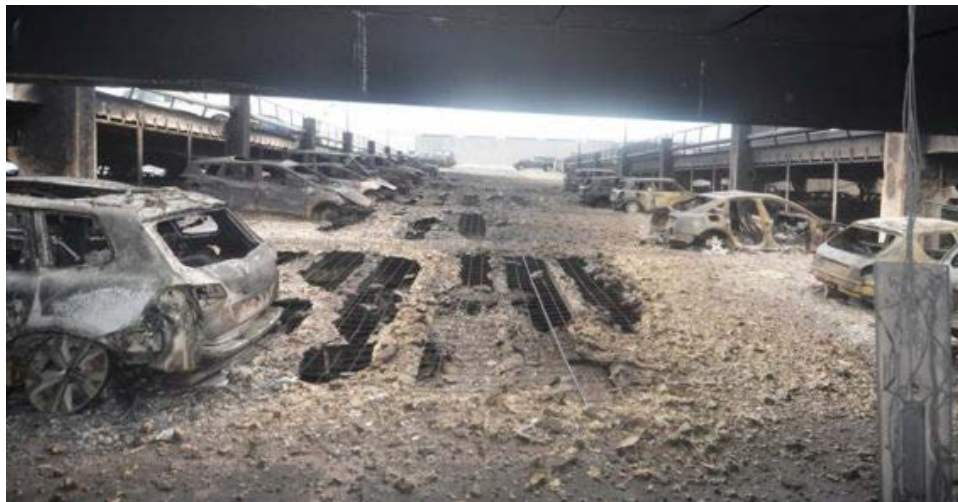
Figure 14 – Concrete spalling in Liverpool, England 2017 fire.

Concrete spalling is reliant on high temperatures over a long period of time, potentially several hours, and is a complex phenomenon that is difficult to predict [Hertz, 2003]. But generally, internal concrete temperatures are required to reach at least 374°C, the critical point of steam. Any constant exposure above this level can eventually lead to spalling, and the higher the concrete temperature the quicker it occurs. Significant spalling was observed in both the Liverpool, England 2017 fire (see Figure 14) and the Stavanger, Norway 2020 parking garage fire (Figure 15). The spalling created large penetrations between the different garage levels and undoubtedly contributed to vertical fire spread. It is important to note that spalling typically occurs several hours into the fire once it had grown to a substantial size [Hertz, 2003]. The spalling phenomenon is highly unlikely to have any effect on the early phases of the fire. It is not unique to vehicle fires and has the potential to occur in any building with uncontrolled fire spread through a large fuel load.

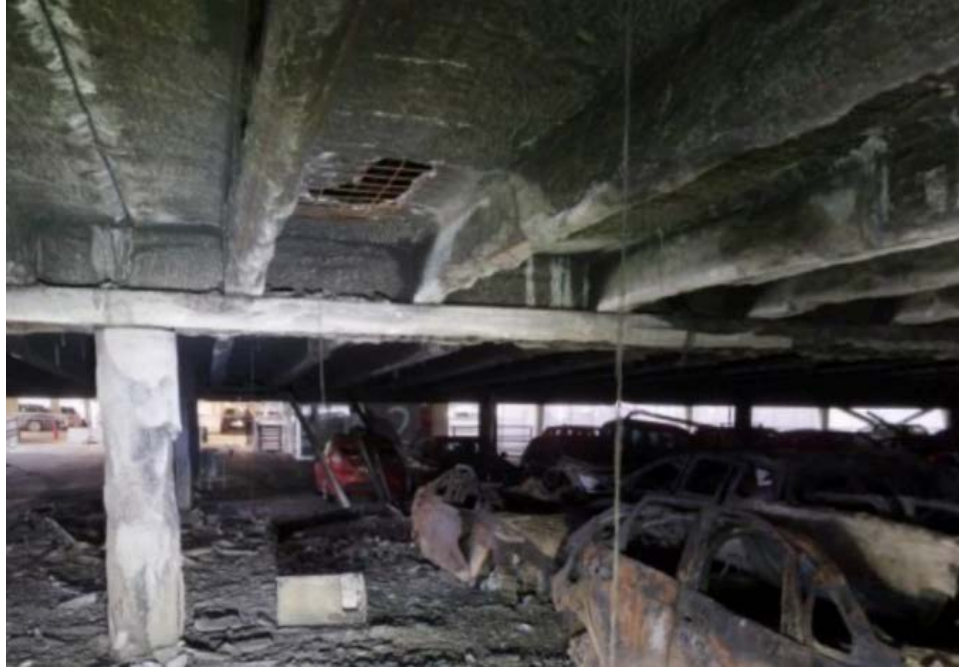
Figure 15 – Concrete spalling in Stavanger, Norway 2020 fire.

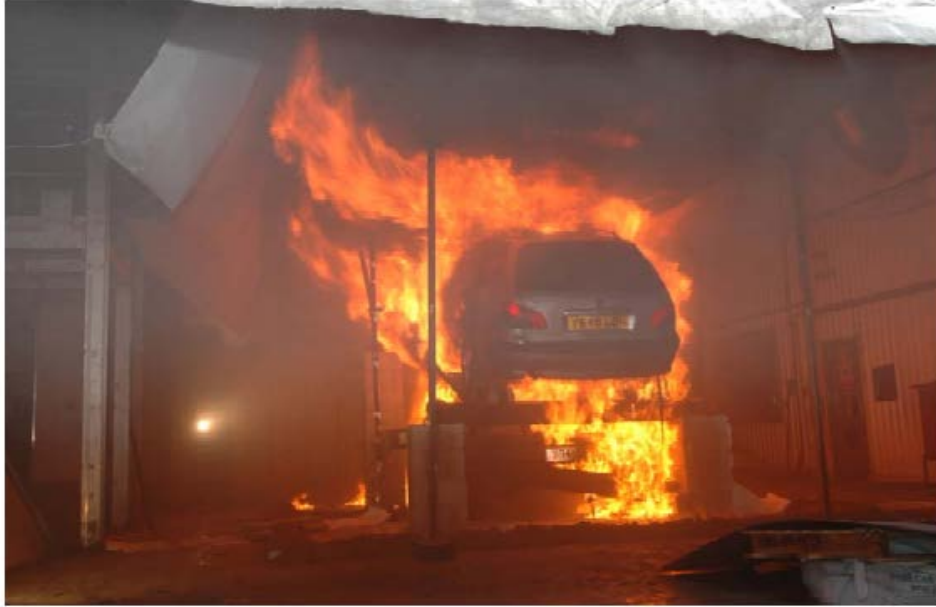
Figure 17 – Non-sprinklered test at 10 min [BRE, 2010].

A single test of a sprinklered two-car stacker configuration was performed by BRE in September of 2009 [BRE, 2009]. This test showed that sprinklers placed overhead contained the fire to the lower vehicle, allowed some spread to the above vehicle, but prevented it from becoming fully involved. This was a replication of a test performed with no sprinkler protection in January 2009 [BRE, 2010] where both vehicles became fully involved and consumed by the fire.

The fire was ignited on the seat of the lower vehicle. After 13 minutes the first roof sprinkler activated, followed by a second at 23 min, and were left on for one hour before being shut off. The fire continued to burn after this. After the test it was found that the lower vehicle was almost entirely consumed by the fire, while the upper vehicle suffered significant exterior and engine compartment damage, but fire never spread to the interior. The test showed that two activated overhead sprinklers control and limit the spread of the fire in the stacker system, but does not extinguish the fire, nor prevent total consumption of the lower vehicle. As a comparison of the fire development, the non-sprinklered test at 10 min is shown in Figure 17, while the sprinklered test at 1 hour 23 min is shown in Figure 18.

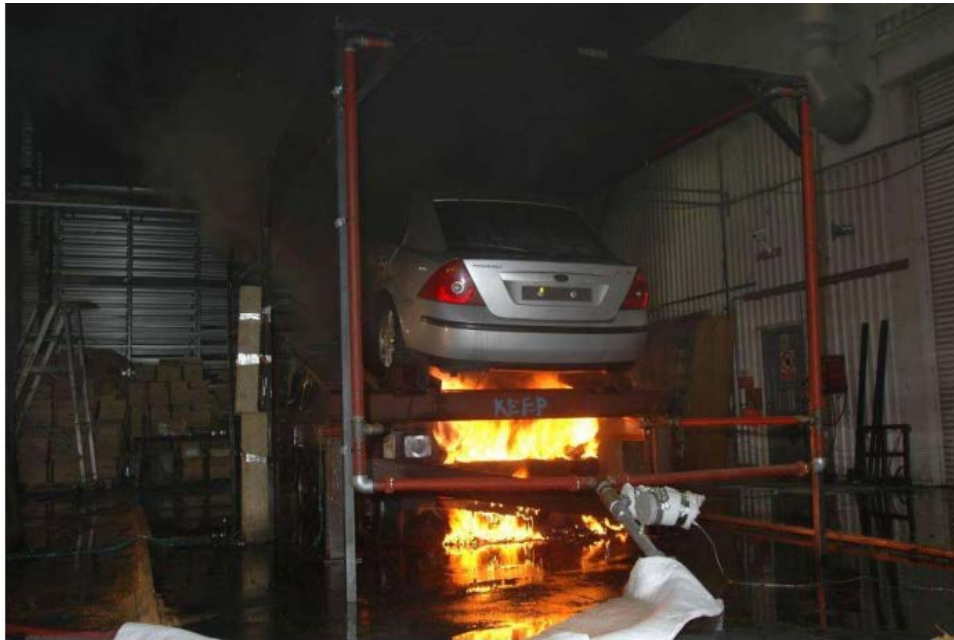
Figure 18 - Sprinklered test at 1 hour, 23 min [BRE, 2009].
